## MONTEREY COUNTY PLANNING COMMISSION

| <b>Project Description:</b> Combined Development Permit as an after-the-fact permit consisting of:<br>1) Coastal Development Permit allowing bluff stabilization/erosion control to prevent structural damage from tidal erosion of terrace deposits and overlying soils. The artificial rock fascia is designed to match the existing shoreline contour, texture and color; 2) a Coastal Development Permit to allow development within 100 feet of environmentally sensitive habitat; 3) a Coastal Development Permit to allow development on slopes of 30% or greater; and 4) a Coastal Development Permit for development within 750 feet of a known archaeological resource. | |
| <b>Project Location:</b> 3158 17-Mile Drive in the Del Monte Forest area of Pebble Beach | <b>APN:</b> 008-491-013-000 |
| <b>Planning File Number:</b> PLN100670 | <b>Owner:</b> Peter Read<br><b>Agent:</b> John Bridges |

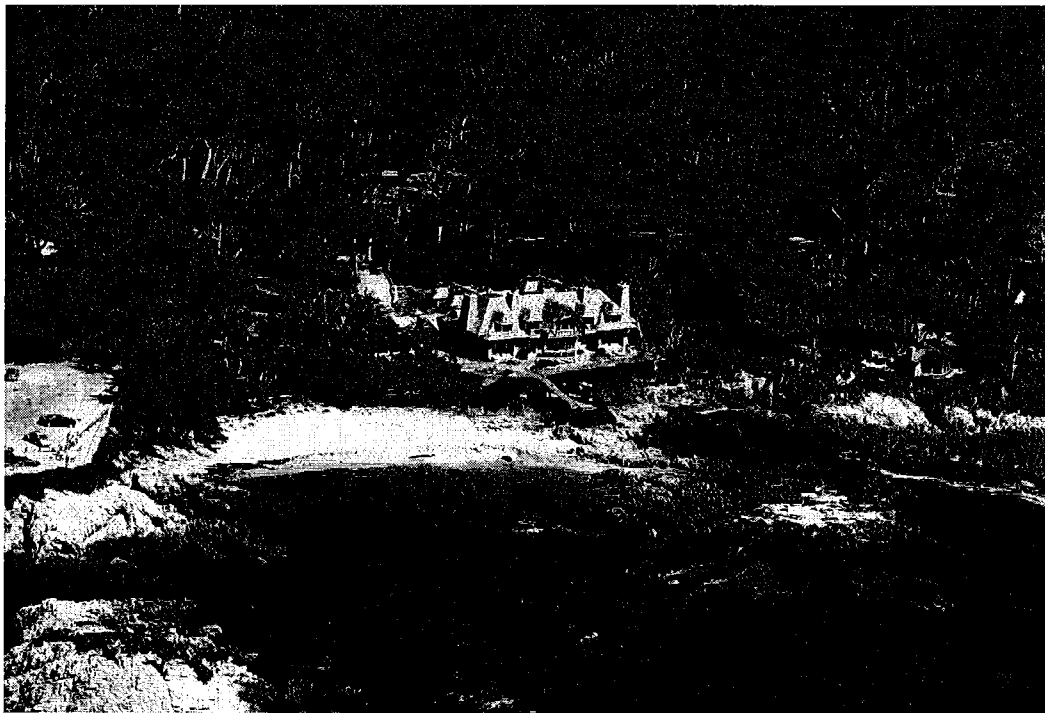
2012 aerial photograph of Read home with bluff area protected on right side of home, where there is a narrow rocky cove. Otter Cove beach is to the left.

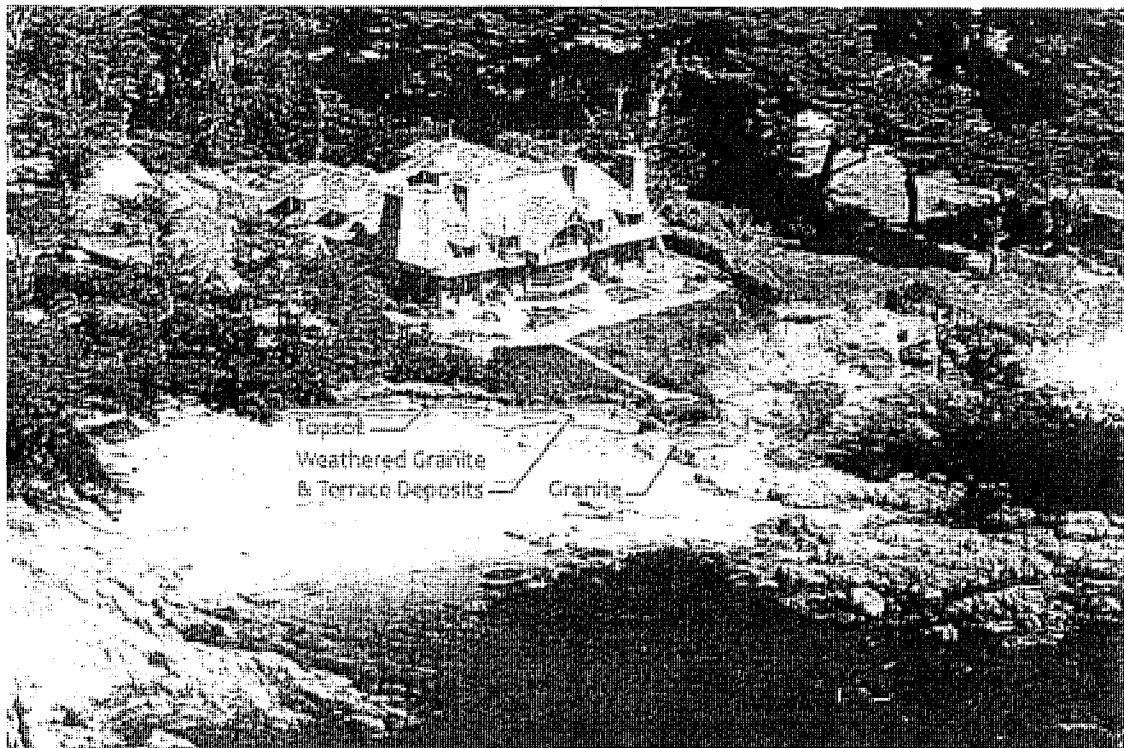
Figure 2. 2008 aerial photograph of the Read home showing the distribution of granite and overlying terrace deposits and soil across the bluff fronting the home site. Note general lack of beach below the bluff in front of the house.

The elevation of the top of the granitic bedrock varies across the front of the property. Along most of the northern side of the parcel, landward of Otter Cove beach, the granite is below beach level and not exposed (Figure 2). The cove itself and the beach are present because of the lower topographic elevations and the fact that the surface of the granitic bedrock is lower. The granite bedrock, along with the overlying terrace deposits, is higher on either side of the cove, including the area beneath and fronting the house site (Figure 2).

A wide sandy beach does not front the section of eroding bluff proposed for protection in front of the Read home (Figure 2). A portion of the eroding area proposed for protection is fronted by a cove eroded into granite about 50 feet across. Granite outcrops form the rear and both sides of the cove as well as most of the intertidal zone. There is a very small pocket beach on the southern end of the cove about 25 feet wide. This beach consists of a mixture of granite boulders, cobbles, gravel and very coarse-grained sand (Figure 13). Most of the sand moves offshore in the winter months, and sediment in the small cove is dominated by boulders, cobbles and gravel (Figure 16).

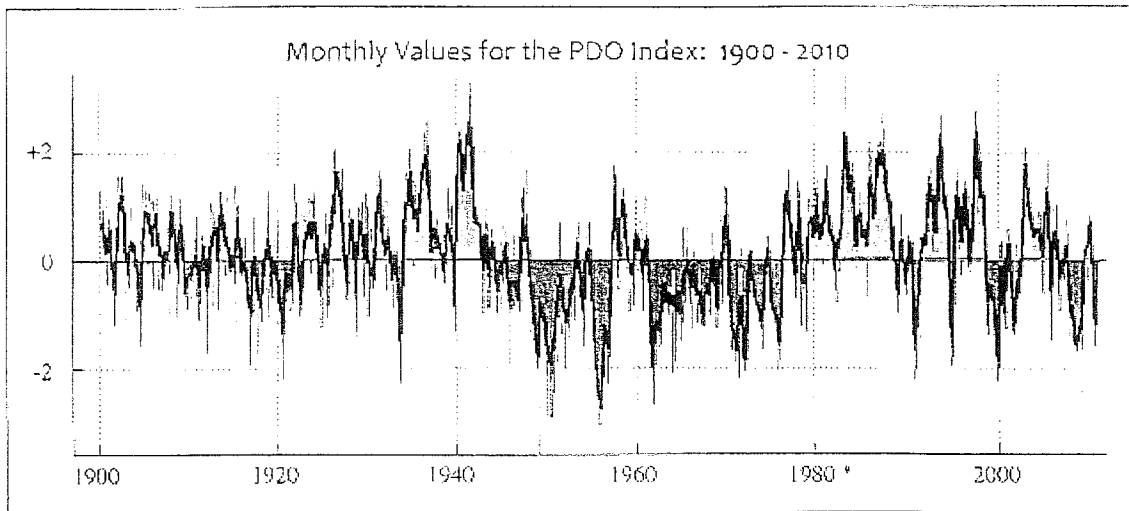
Figure 3. Pacific Decadal Oscillation (PDO) cycles for past century. Vertical axis is a dimensionless scale that was developed to include a number of atmospheric and meteorologic variables.

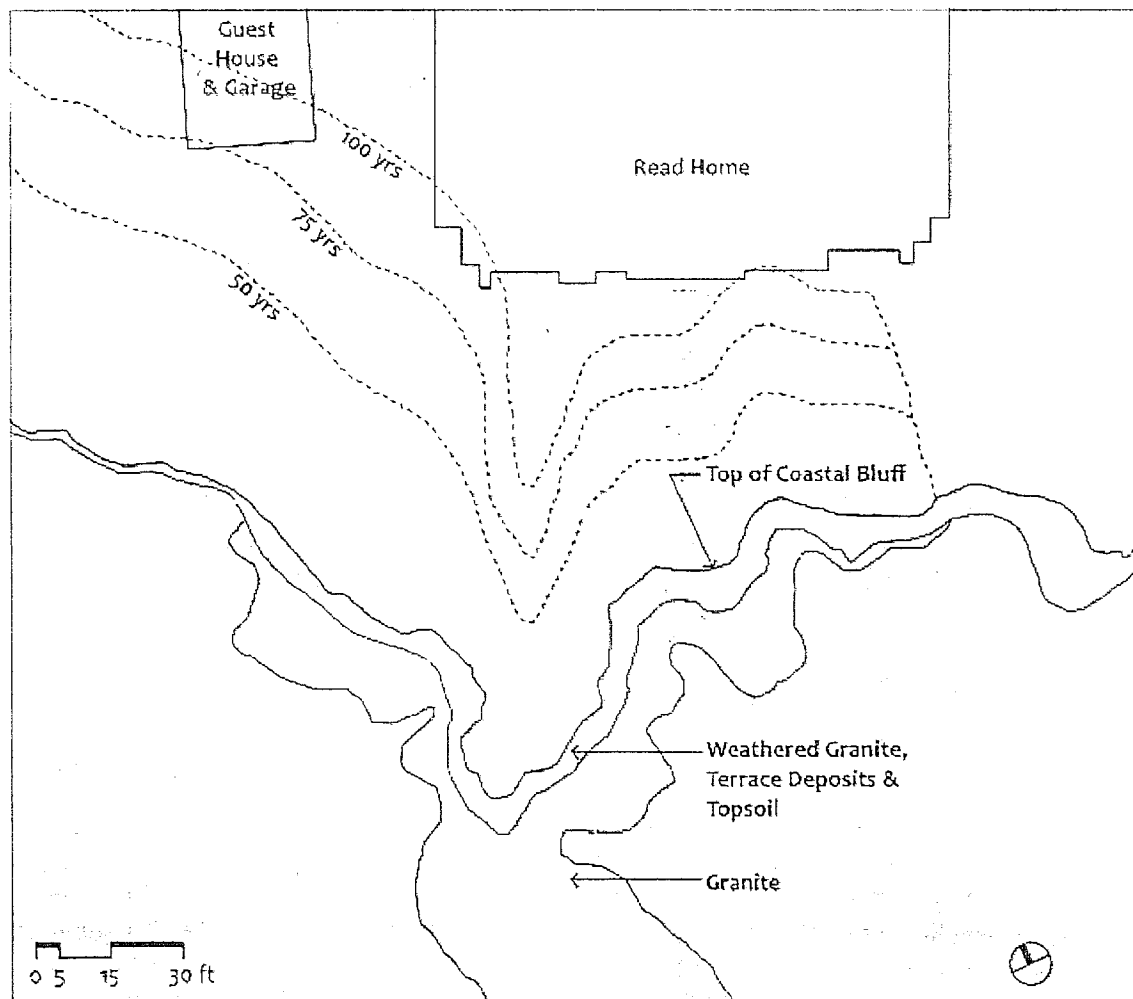
Figure 5. Projected 50, 75, 100 - year erosion lines from top of coastal bluff, from Nielsen and Associates (2004)

Nielsen & Associates concluded, however, that these rates were too conservative and used a safety factor of 1.5 to increase potential erosion rates from 0.3 and 0.5 ft/yr to 0.45 to 0.75 ft/yr. Using these rates, which decrease from north to south, setbacks for 50, 75 and 100 year periods were designated. The projected 75-yr erosion line based on those erosion rates intersects the guesthouse, and the projected 100-yr erosion line intersects the front of the Read home and passes through the garage/guest house (Figure 5). The architect of the home (International Design Group) has stated that it was designed for a 200-year life.

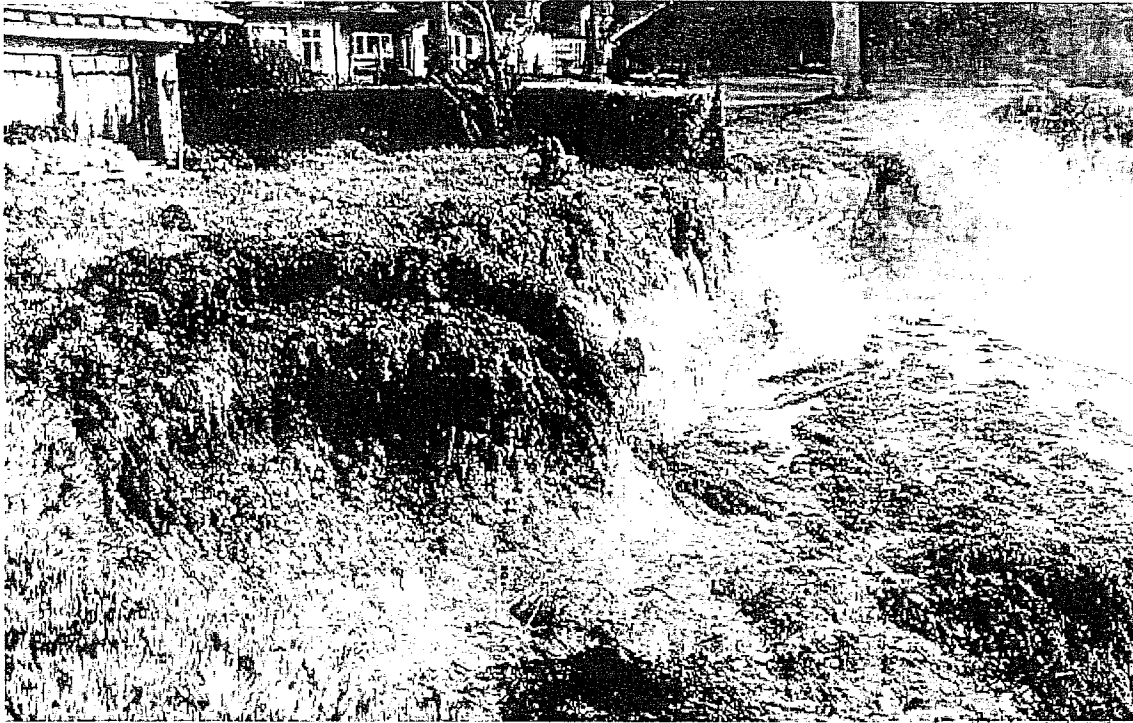
Figure 7. Wave overtopping the bluff immediately in front of the Read home at 10:15 on morning of January 5, 2008.

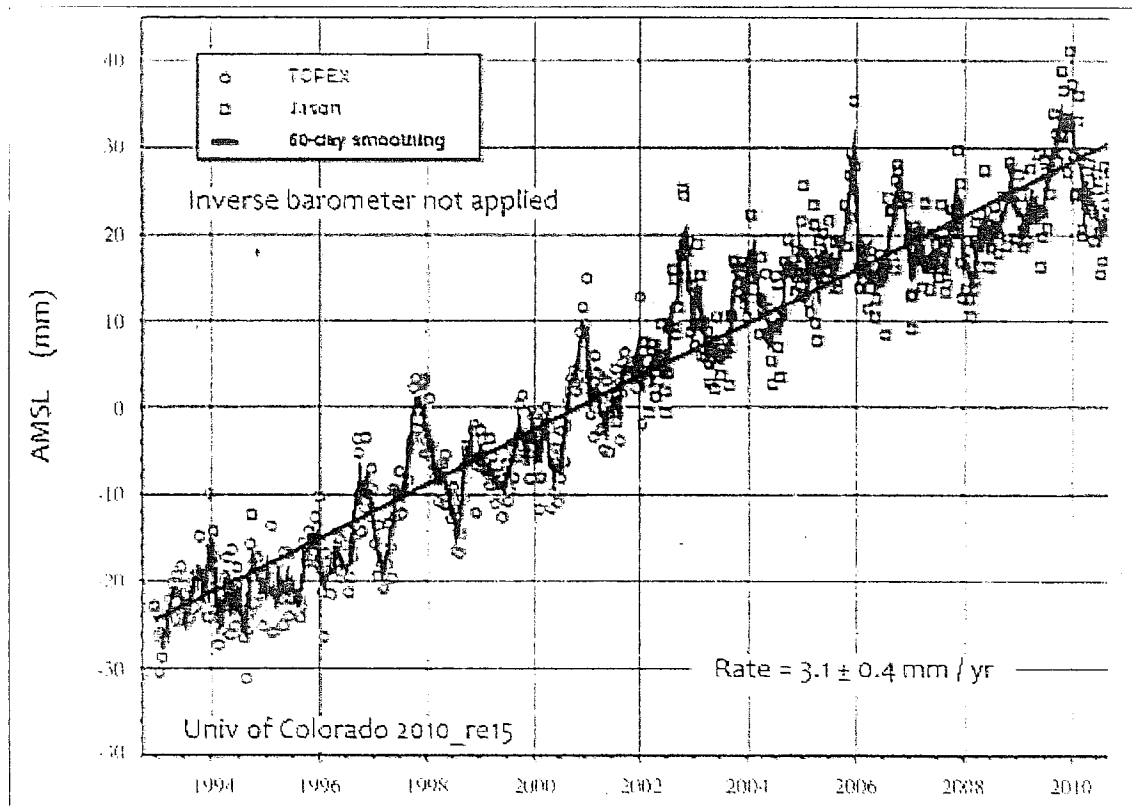
Figure 8. Satellite altimetry record of sea level rise since 1992

Beginning in 1993, the Topex-Poseidon and then Jason satellites have been able to accurately measure sea levels from space using satellite altimetry without having to separate out the local land effects, and have documented an average global sea level rise rate of  $3.1 \text{ mm/yr}$  between 1993 and 2009 (Figure 8). This represents nearly a doubling of the  $1.7\text{-}1.8 \text{ mm/yr}$  rate used by the IPCC for the past century.

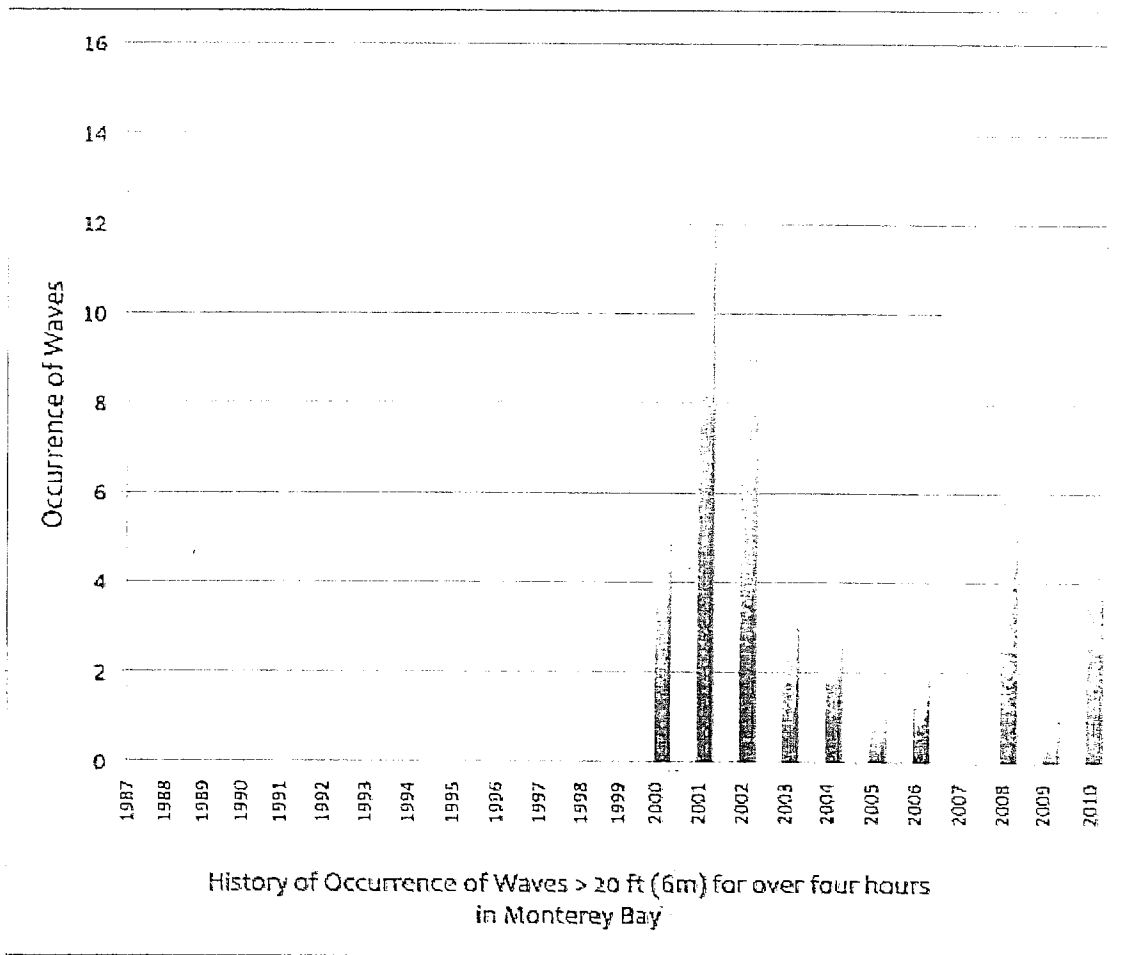
Figure 10. Historic occurrence of waves greater than 20 ft (6 m) for over 4 hours at the Monterey Bay, California Data Information Program (CDIP) buoy.

A search of the Monterey Bay buoy historic data for occurrences of large waves (the search was defined by at least 4 hours of wave heights of greater than 6 meters or ~20 feet) indicate that in the 12 year period between 1987 and 1999 there were no such events. Conditions changed beginning in 2000, however, and between January 2000 and January 2010, there have been 49 occurrences of waves greater than 20 ft for at least 4 hours, with five occurring in January of 2010 alone (Figure 10). This represents a significant recent increase in wave height and energy.

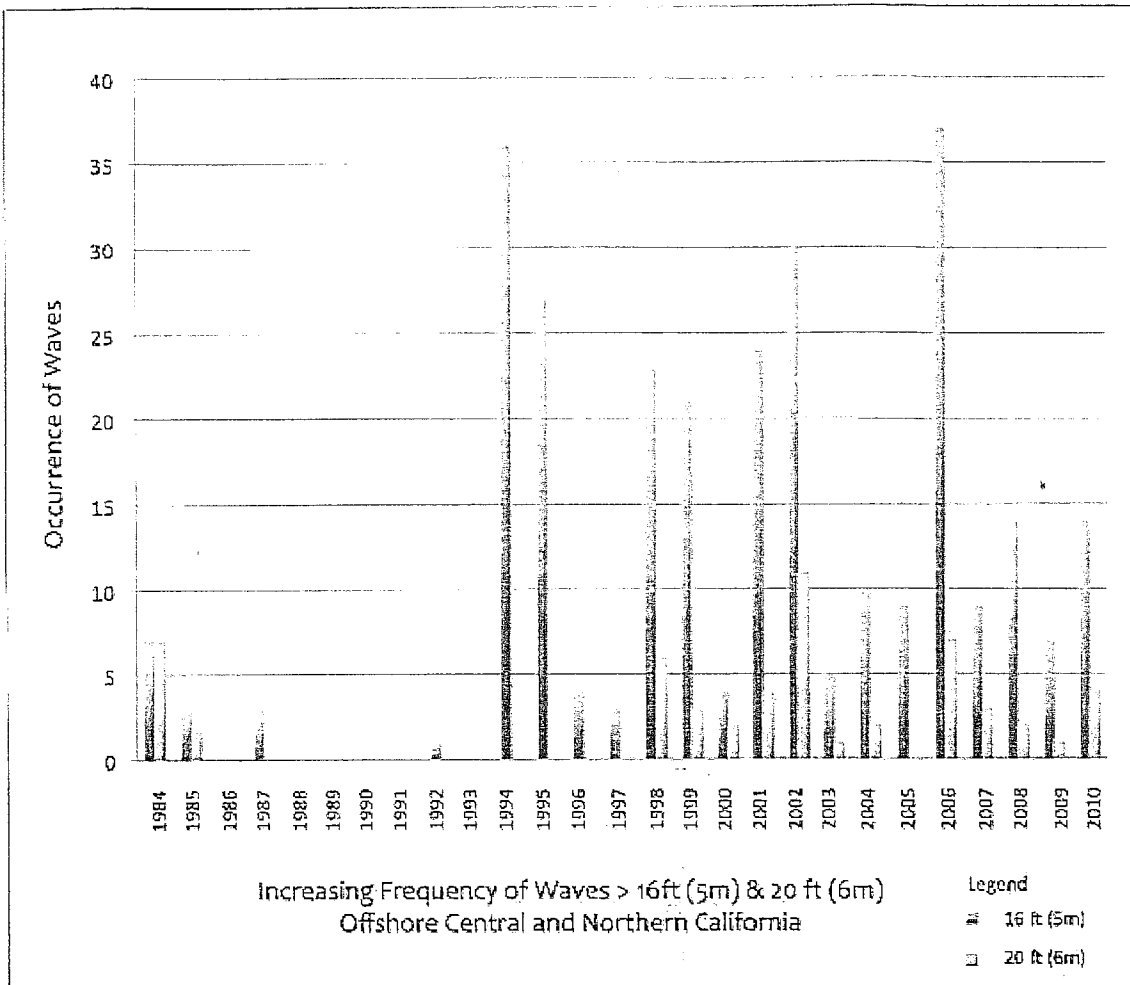
Figure 11. Increasing frequency of waves of at least 16 ft (5m) or 20 ft (6m) in height offshore Central and Northern California.

Lowering the wave height threshold to 5 m (~16 feet), and searching for the events when waves exceeded 5 m or 6 m in the same Central and Northern California region also reveals a significant increase in wave height (and therefore energy) beginning in 1994 (Figure 11). The wave buoys are all indicating substantial increases in wave heights along the central coast, which need to be considered, as they will affect the future risks to any coastal projects, new or existing.

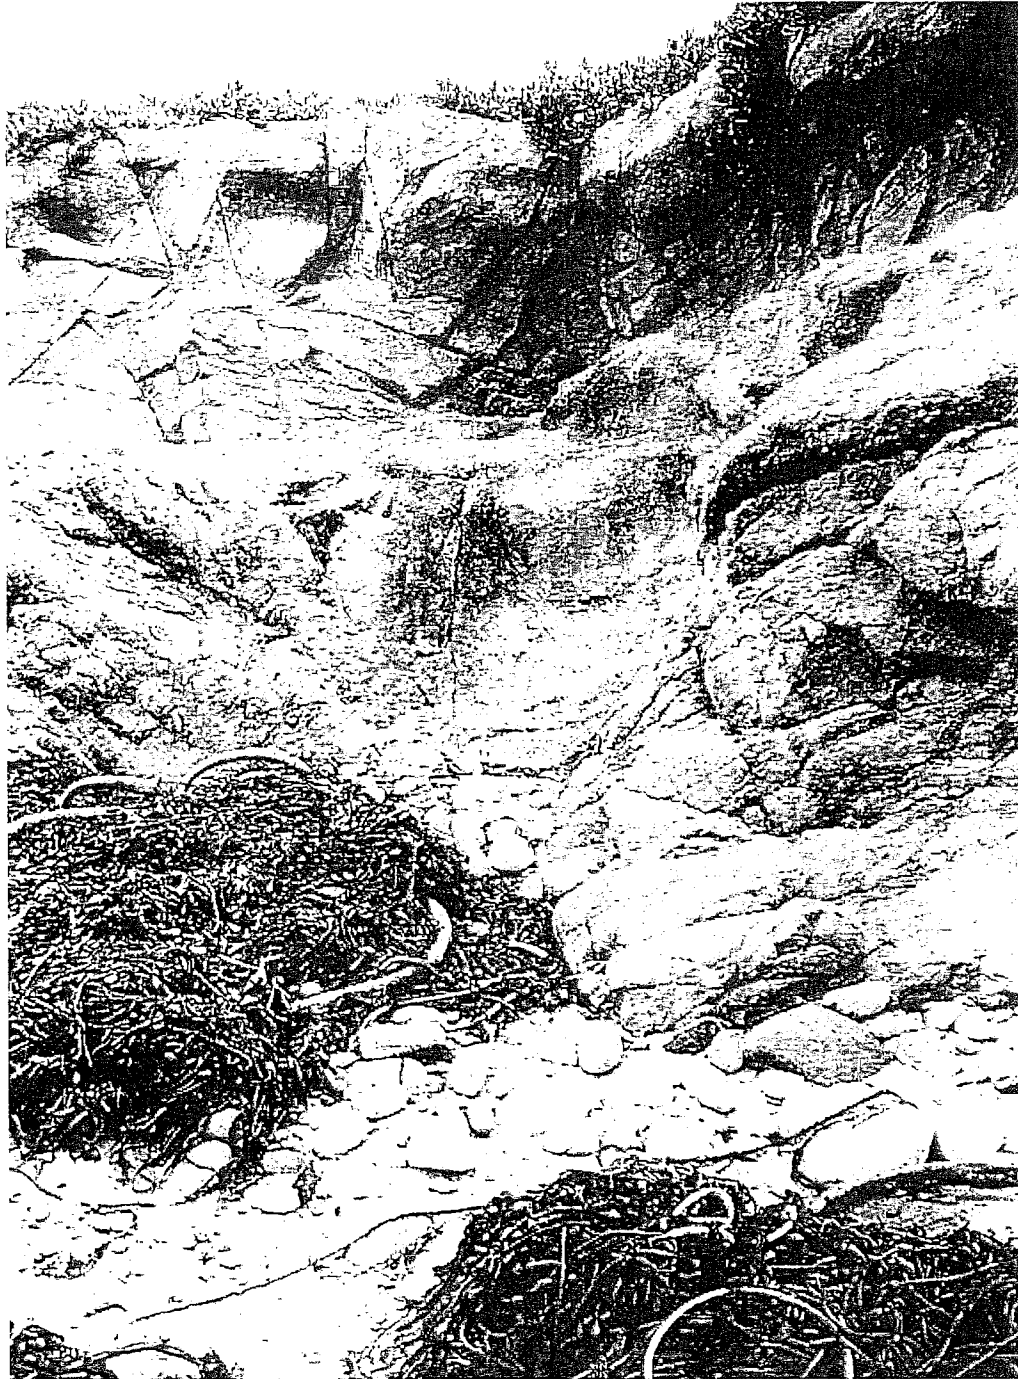
Figure 12. Short section of soil naʻi wall in Pebble Beach area , which mimics and is indistinguishable from the bluff forming granite.

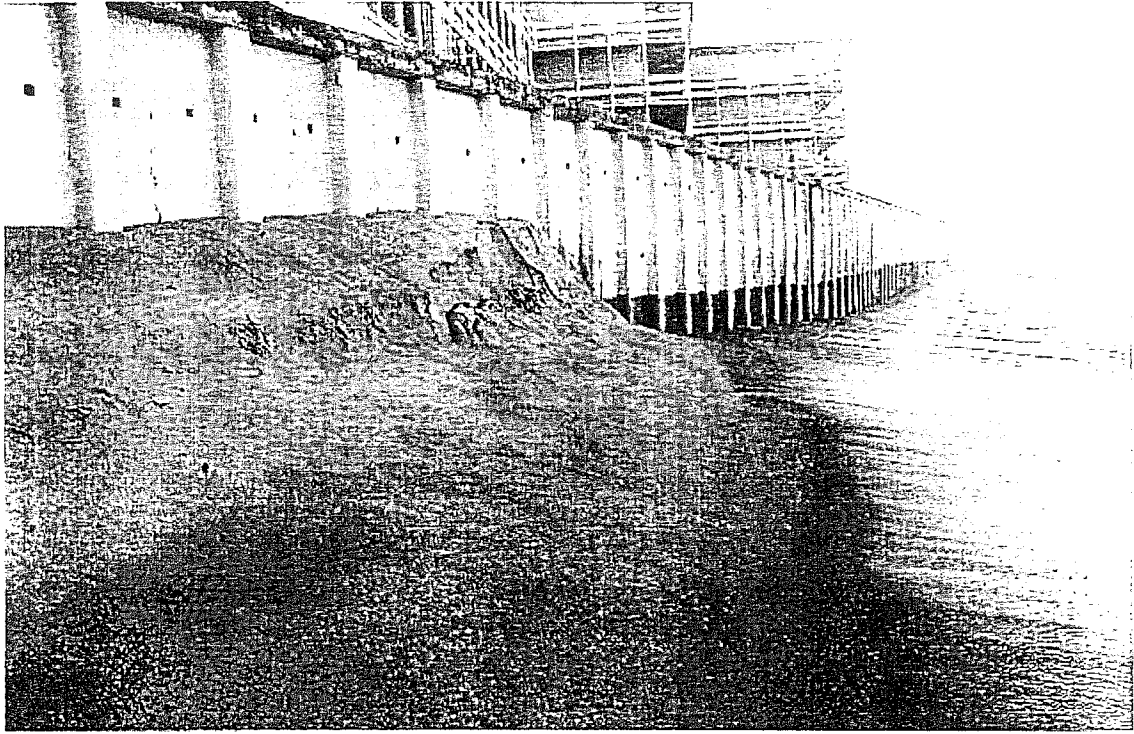
Figure 14. Concrete seawall protecting the Monterey Beach Hotel, which blocks lateral access along the beach at high tides.

- C. Reduction of beach access: lateral or vertical** - Some very large coastal protection structures encroach onto public beaches. The large concrete seawalls protecting both the Monterey Beach Hotel and the Ocean Harbor House complex, for example, (Figures 14 and 15), and therefore, cut off public access along the beach at high tide, or access to the beach from the bluff top. The proposal here is for a 12-inch thick soil nail wall to stabilize the terrace deposits and soil along the bluff top. The proposed structure starts 8 feet above beach level, and doesn't significantly change the existing landforms of affect the beach. There is no loss of beach access because this is not an area where there has ever been public access. *In summary, there is no reduction or loss of beach access.*

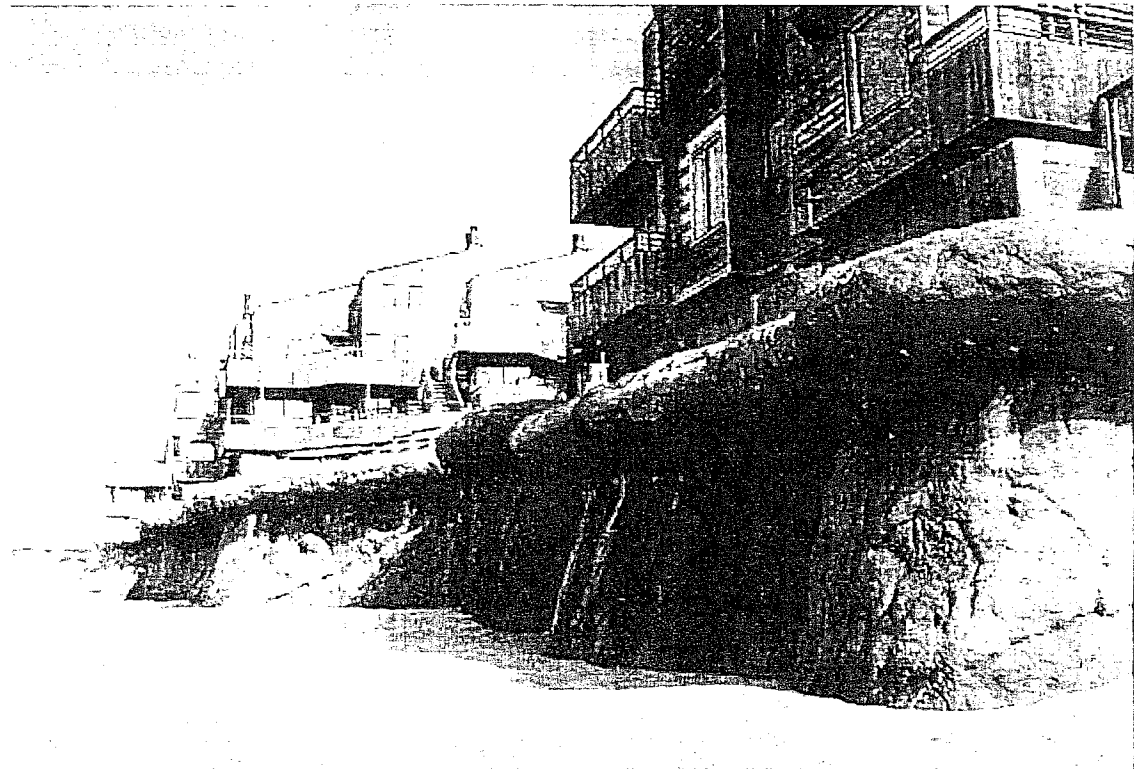
Figure 15. Concrete seawall protecting Ocean Harbor House, which blocks lateral beach access at high tides.

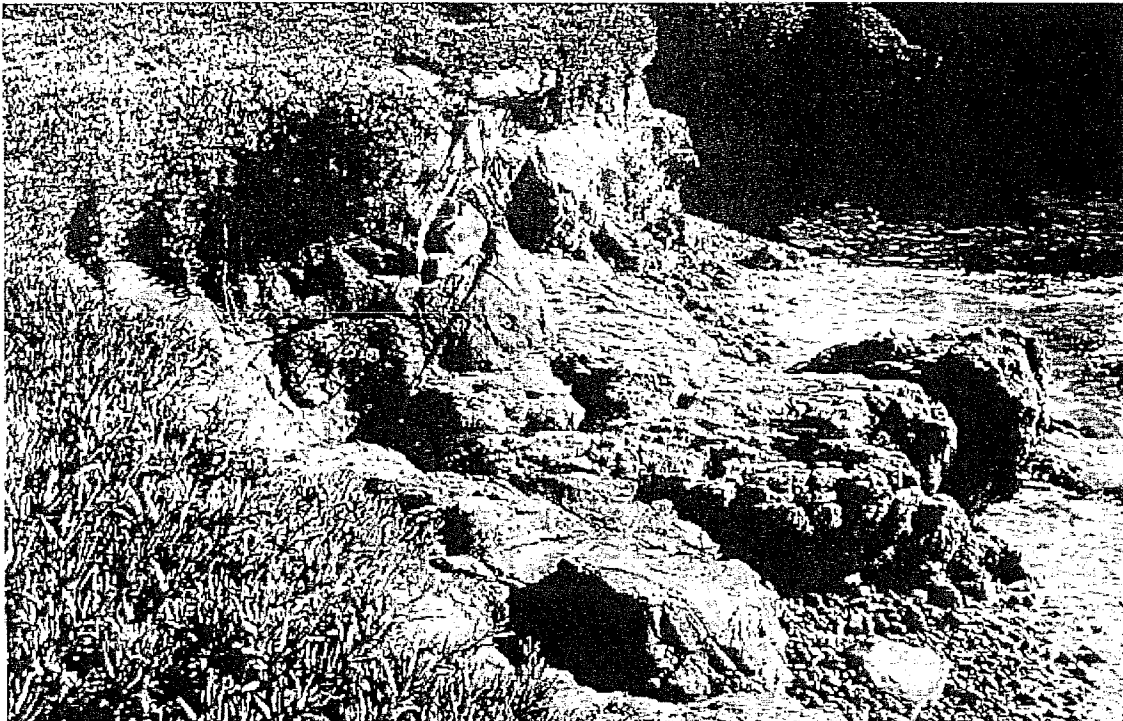
Figure 16. Mixed beach consisting of boulders, cobbles, gravels and some sand in the cove fronting the area proposed for protection.
