MONTEREY COUNTY ZONING ADMINISTRATOR

Meeting: June 26, 2014	Agenda Item No.: 3
Project Description: A Coastal Administrative Permit and Design Approval to allow the demolition of a 3,464 square foot, single family dwelling and associated accessory structures, and the construction of a 6,964 square foot, two-story, single family dwelling with a 760 square attached garage.	
Project Location: 1145 Spyglass Hill Road, Pebble Beach	APN: 008-012-005-000
Planning File Number: PLN130187	Owner: Kerry Straine & Olivia McLeod Agent: John Bridges of Fenton & Keller
Planning Area: Del Monte Forest Land Use Plan	Flagged and staked: Yes
Zoning Designation: : "LDR/1.5-D (CZ) [Low Density Residential, 1.5 acres per unit with Design Control Overlay (Coastal Zone)]	
CEQA Action: Categorically Exempt per Section 15303 (a) and 15333	
Department: RMA - Planning Department

PROPOSED STRAINE RESIDENCE

STRAINE RESIDENCE
 1145 SPYGLASS HILL ROAD
 PEBBLE BEACH, CALIFORNIA
 APN: 008-012-005

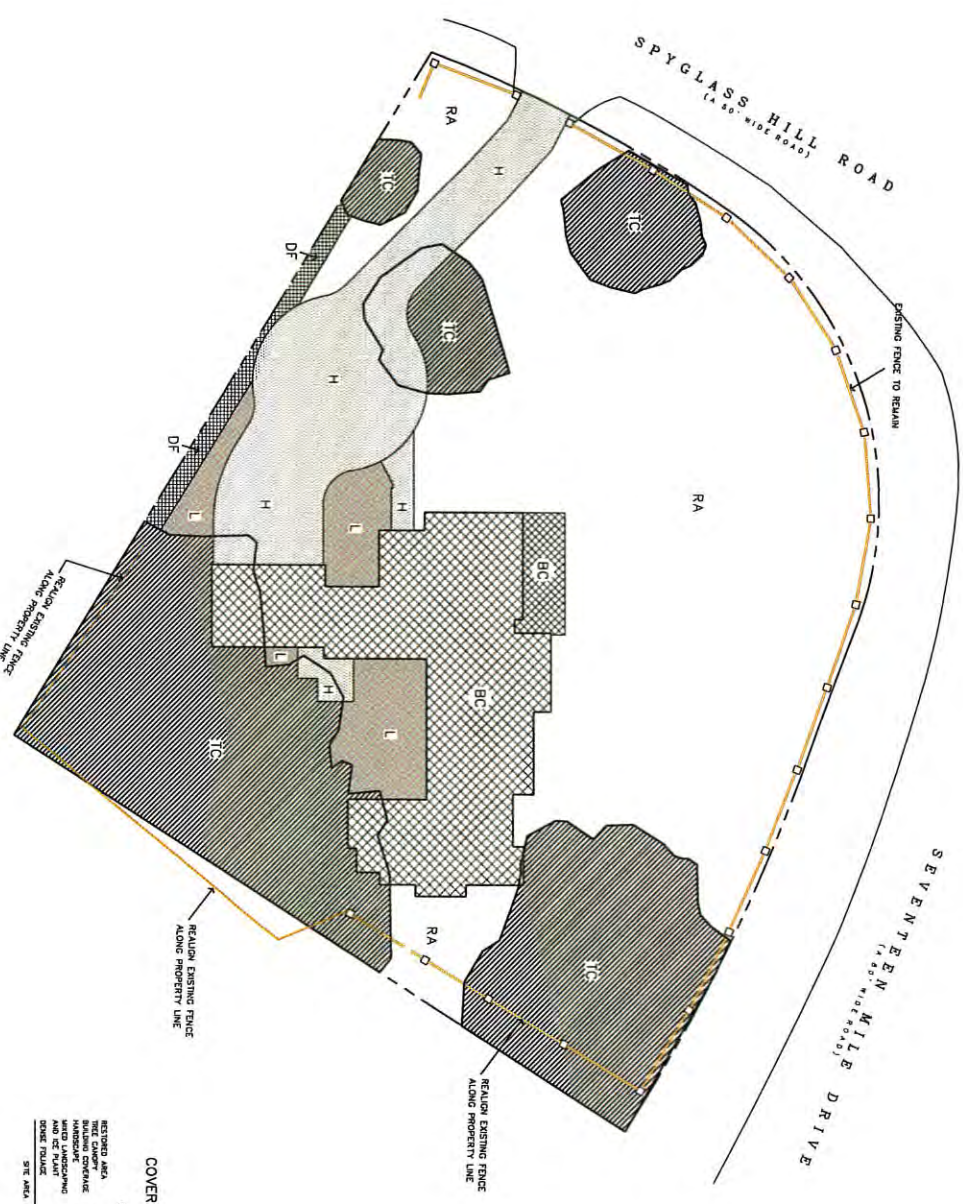
02-1914
JOB NUMBER 1214
PROJECT NUMBER D9

**PROPOSED
COVERAGE AREAS**

- RESTORATION AREA
- TREE CANOPY
- BUILDING COMPLEX
- HARDSCAPE
- LANDSCAPING
- BOND FENCE

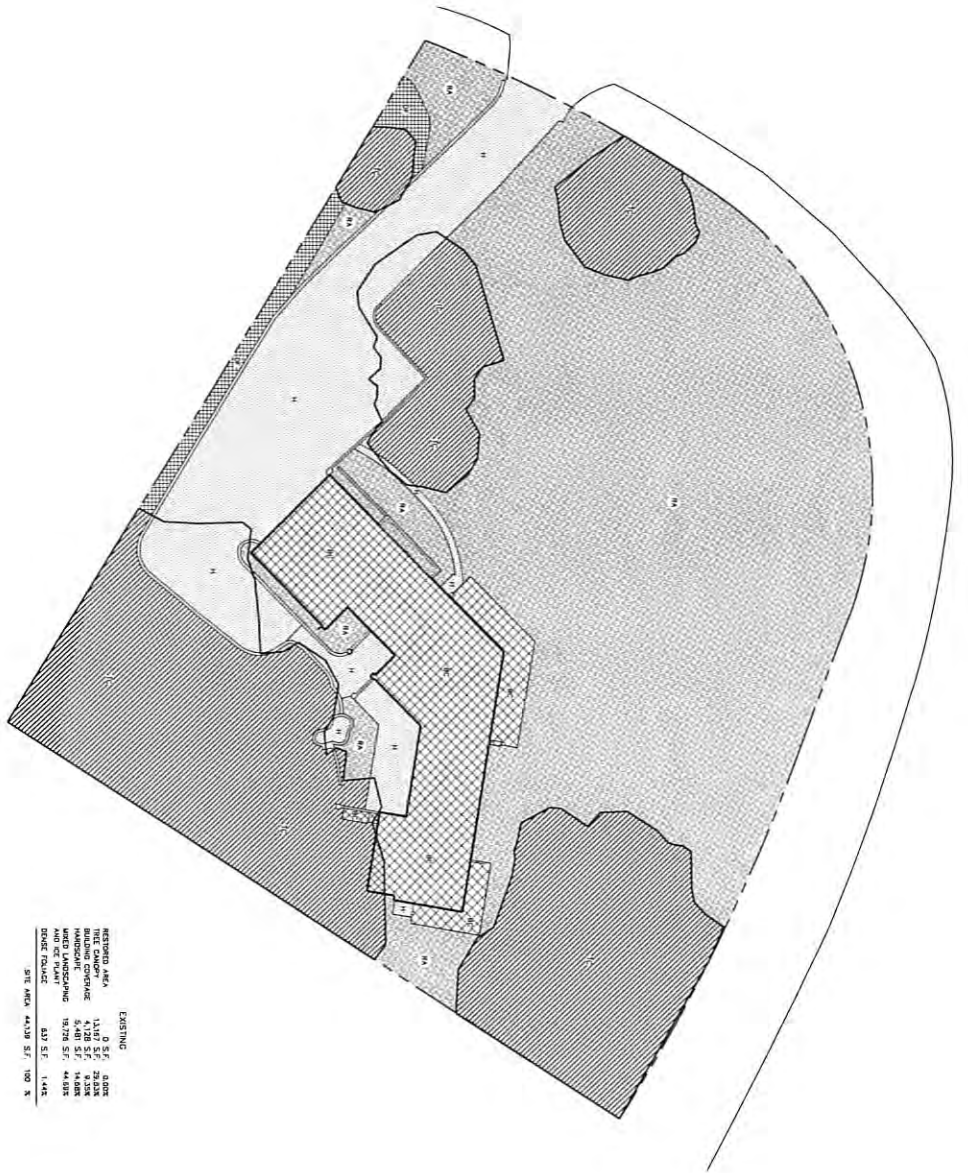
02-19-14
JOB NUMBER 1214
PROJECT NUMBER D10

EXISTING

RESTORATION AREA	110 S.F.	0.00%
TREE CANOPY	1,120 S.F.	2.52%
BUILDING COVERAGE	4,120 S.F.	9.28%
HARDSCAPE	5,410 S.F.	12.21%
LANDSCAPING	18,720 S.F.	42.00%
DRIVE PAVEMENT	430 S.F.	1.04%
SITE AREA	44,310 S.F.	100 %

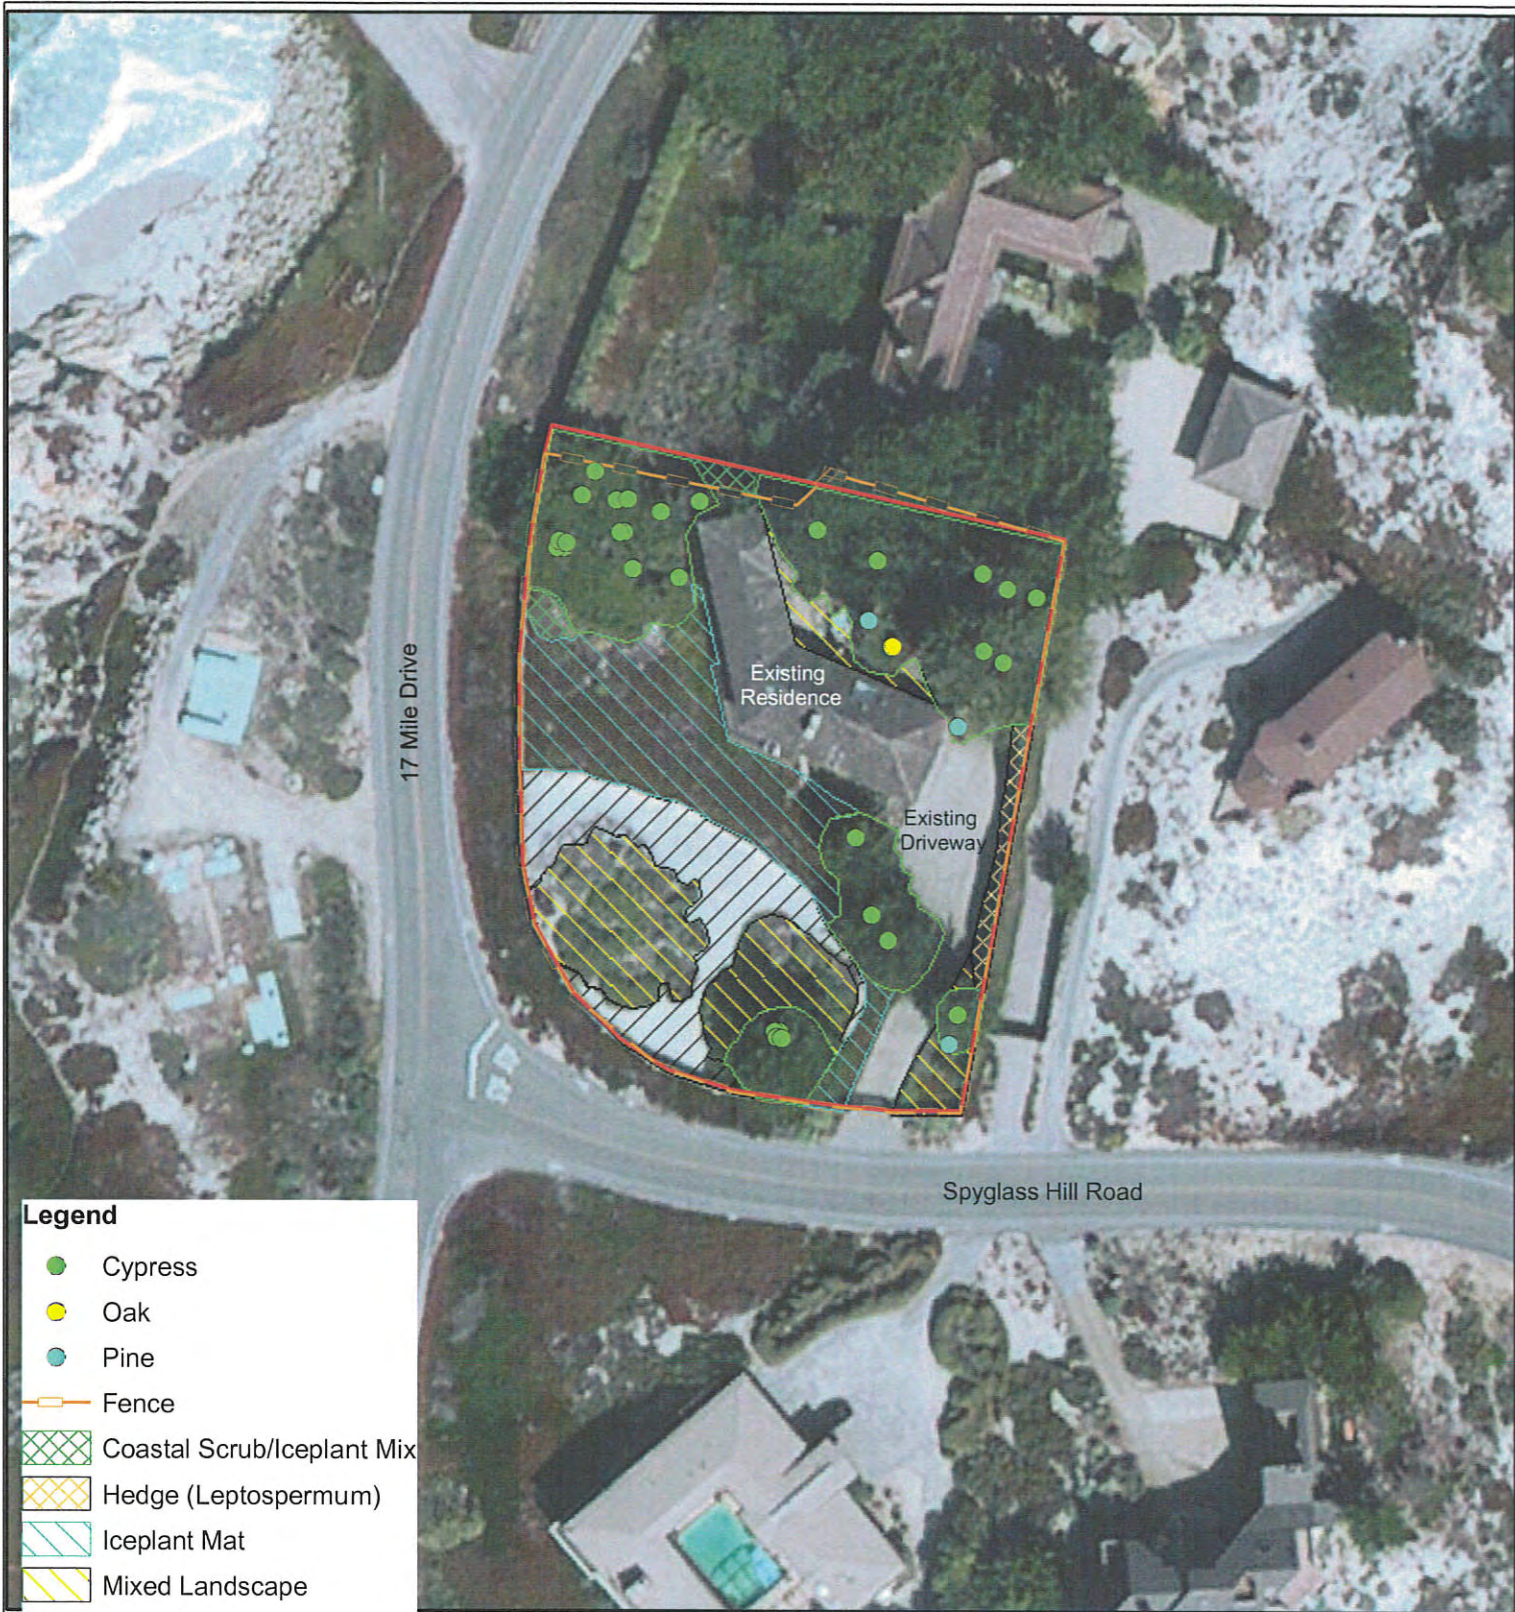
- Legend**
- Cypress
 - Oak
 - Pine
 - Fence
 - Coastal Scrub/Iceplant Mix
 - Hedge (Leptospermum)
 - Iceplant Mat
 - Mixed Landscape
 - Open Sand
 - Tree Canopy
 - Property Boundary

**Existing Conditions and Vegetation Types
Straine Property
Pebble Beach, California**

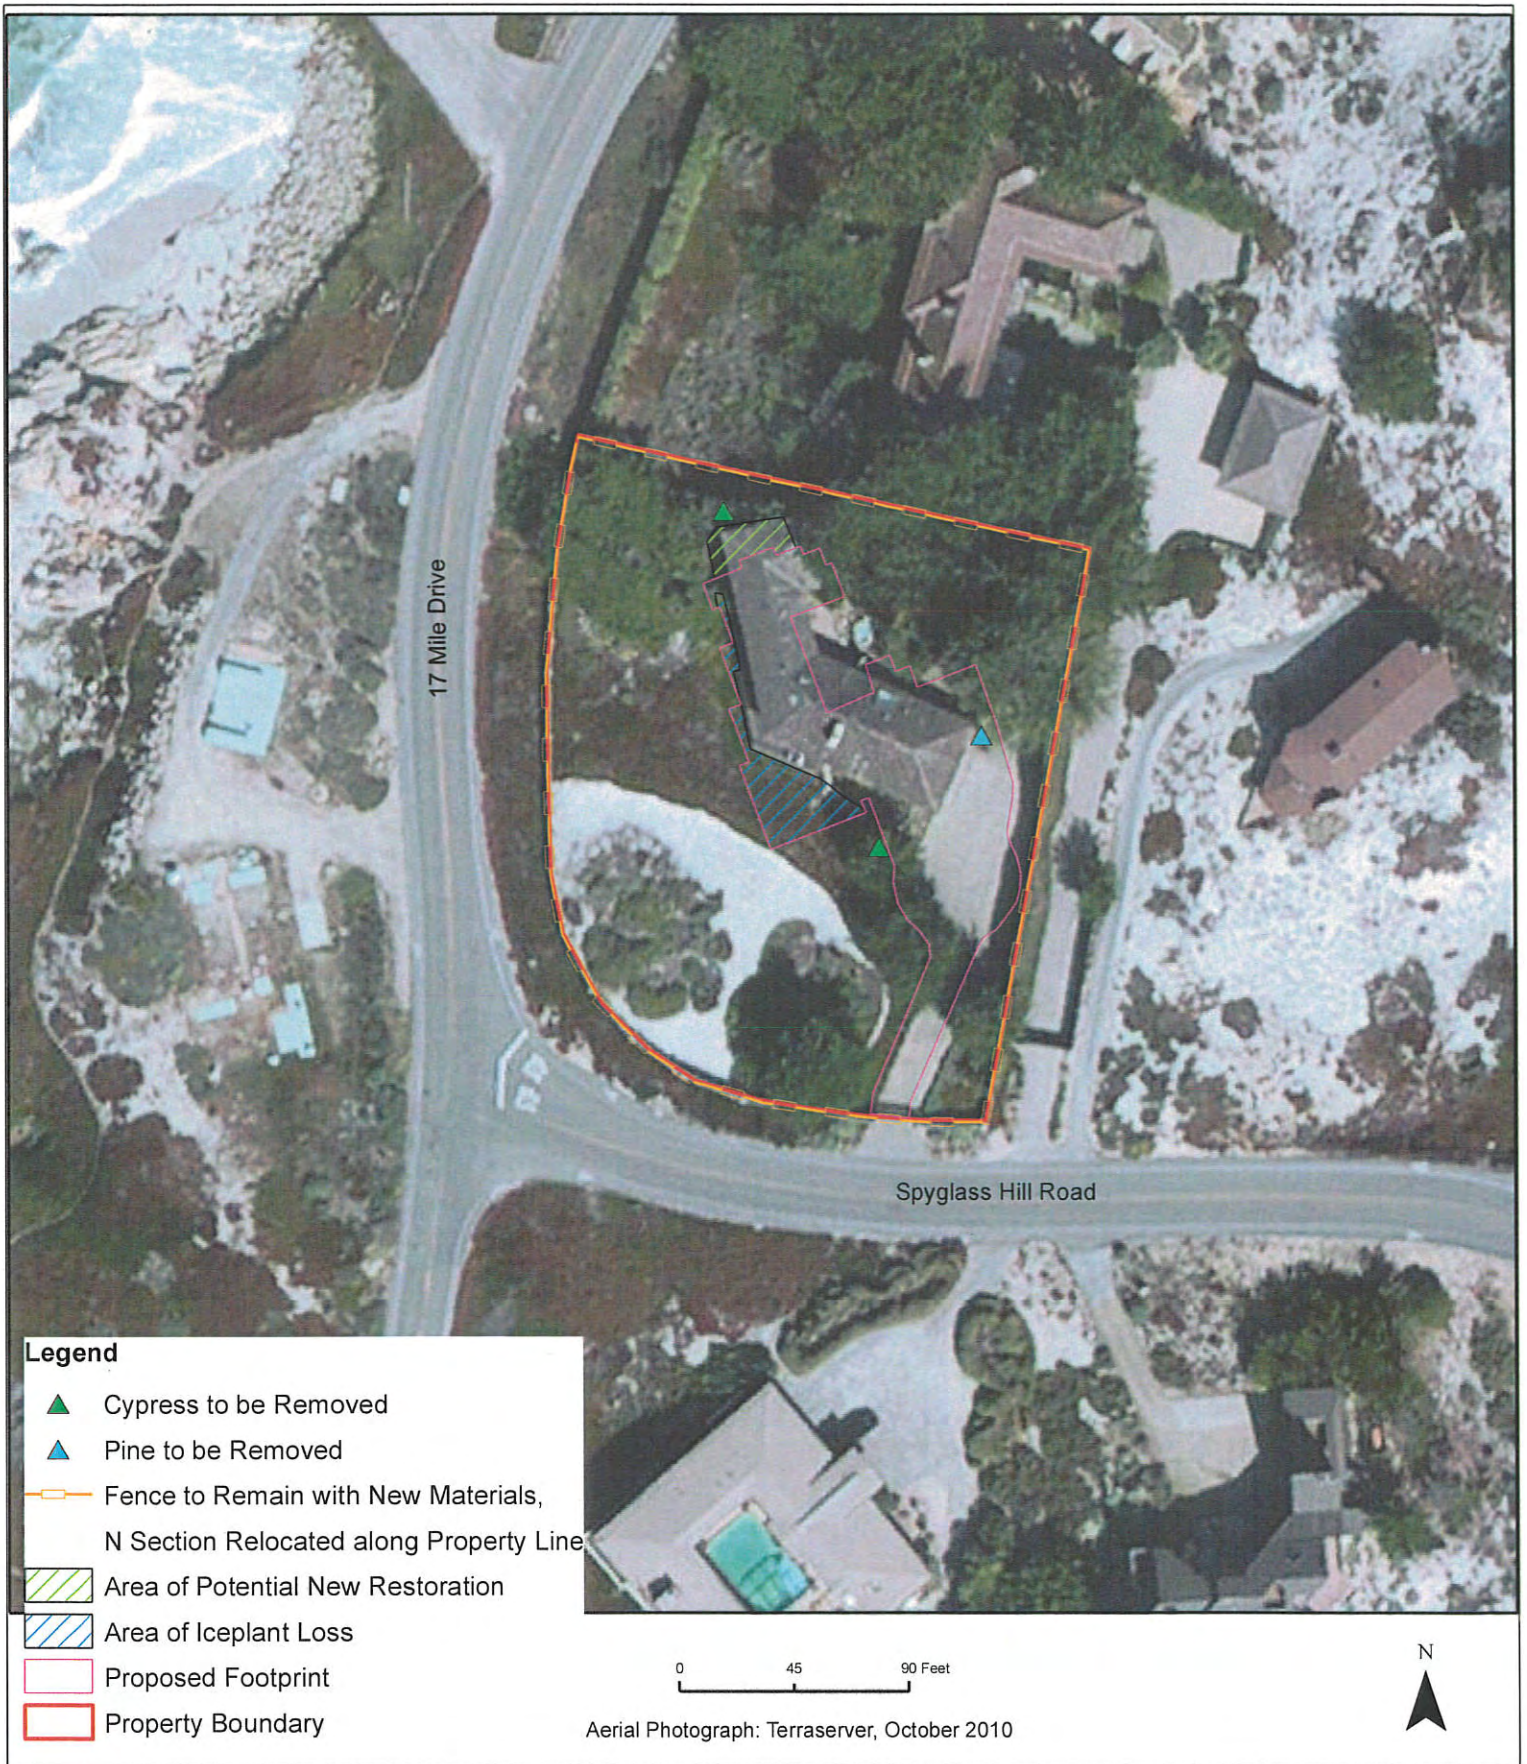
Figure
 3

Areas of Gain and Loss with Proposed Footprint
 Straine Property
 Pebble Beach, California

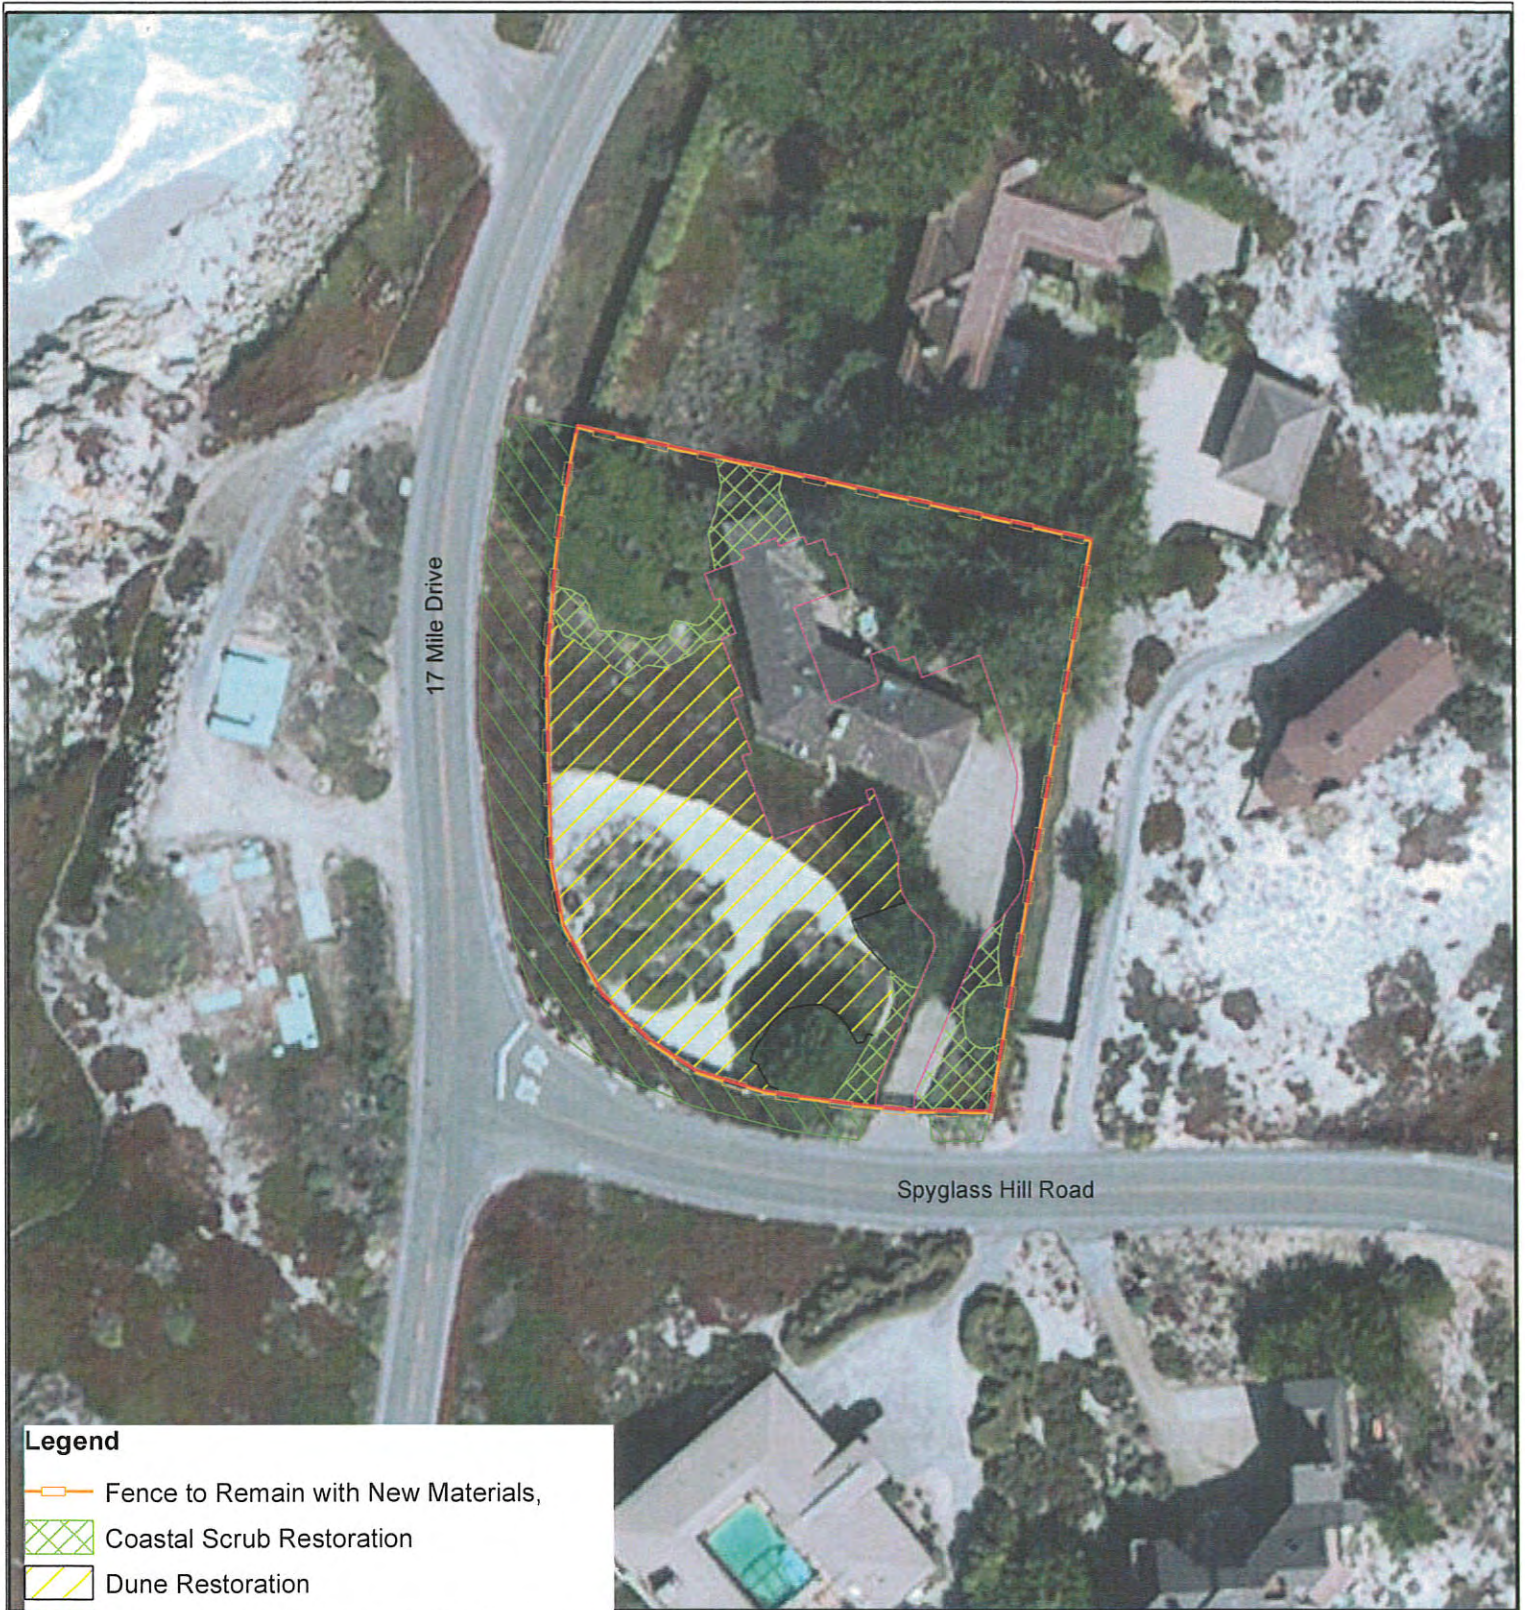
-   Fence to Remain with New Materials,
-   Coastal Scrub Restoration
-   Dune Restoration
-   Proposed Offsite Supplemental Restoration
-   Proposed Footprint
-   Property Boundary

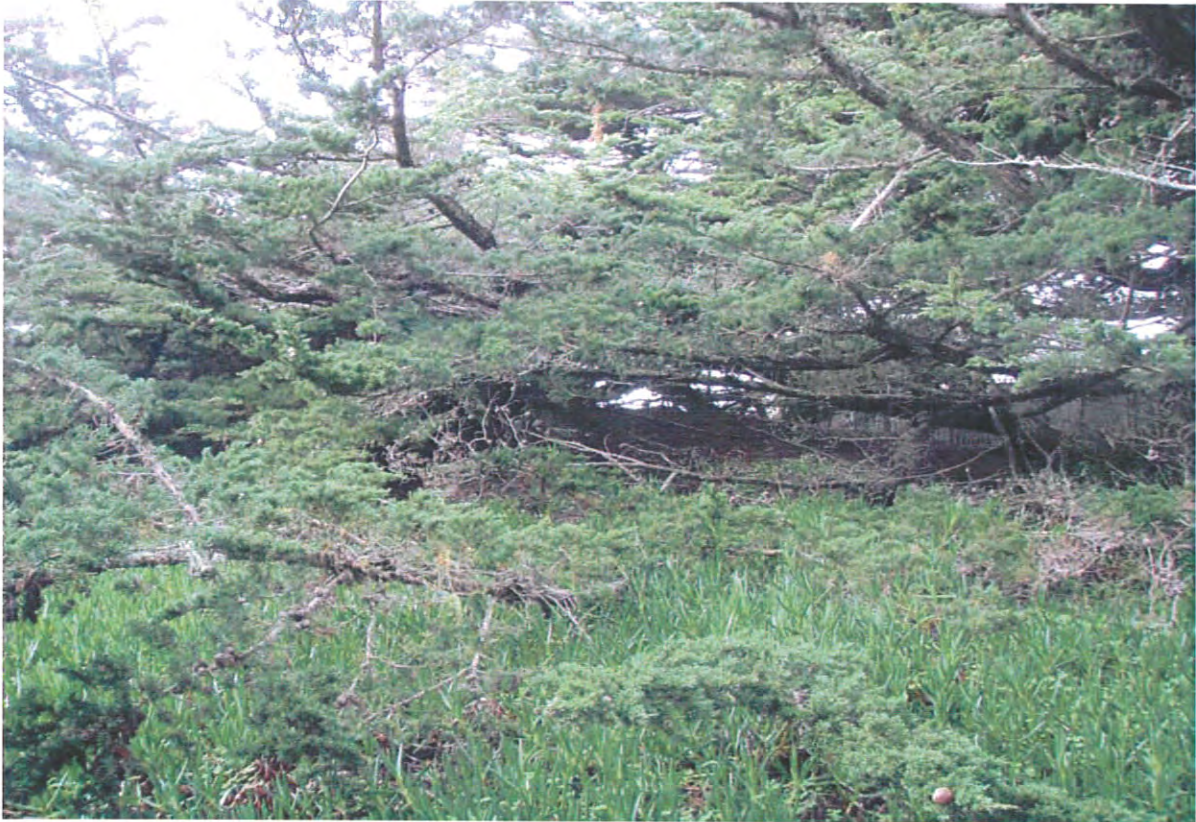
Cypress canopy with iceplant underneath

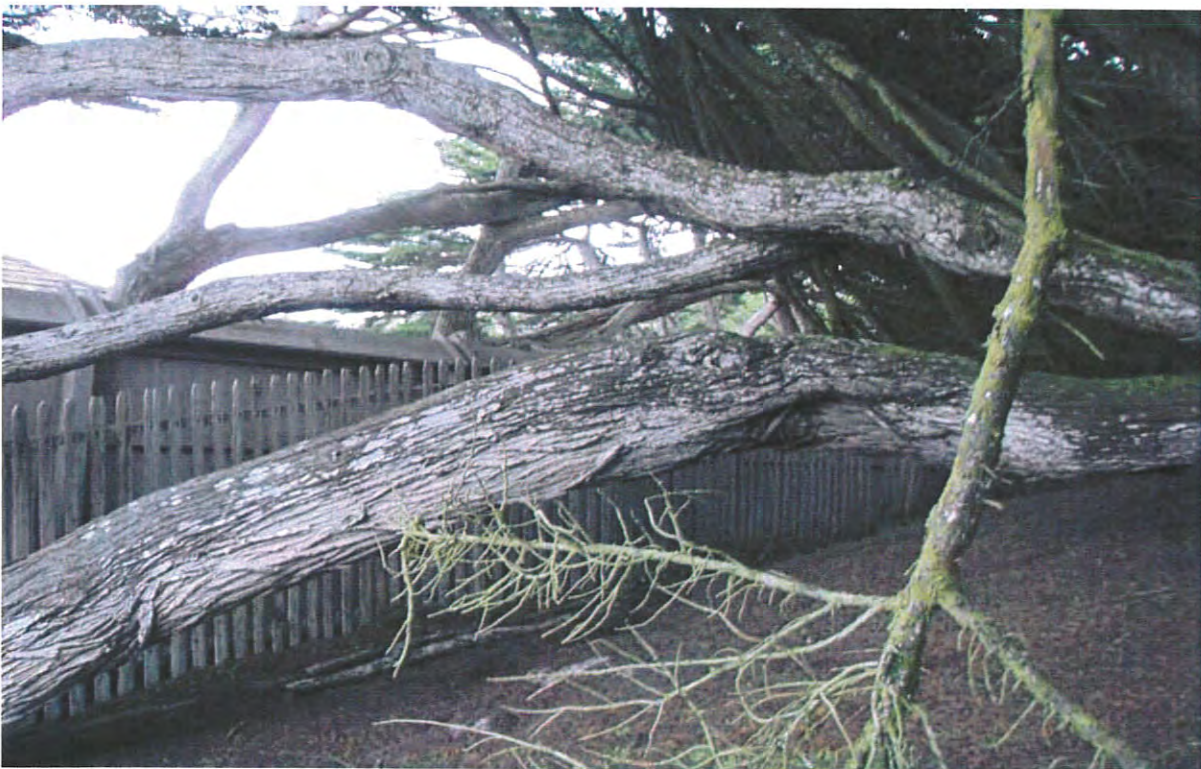
Cypress canopy with barren understory on north side of house

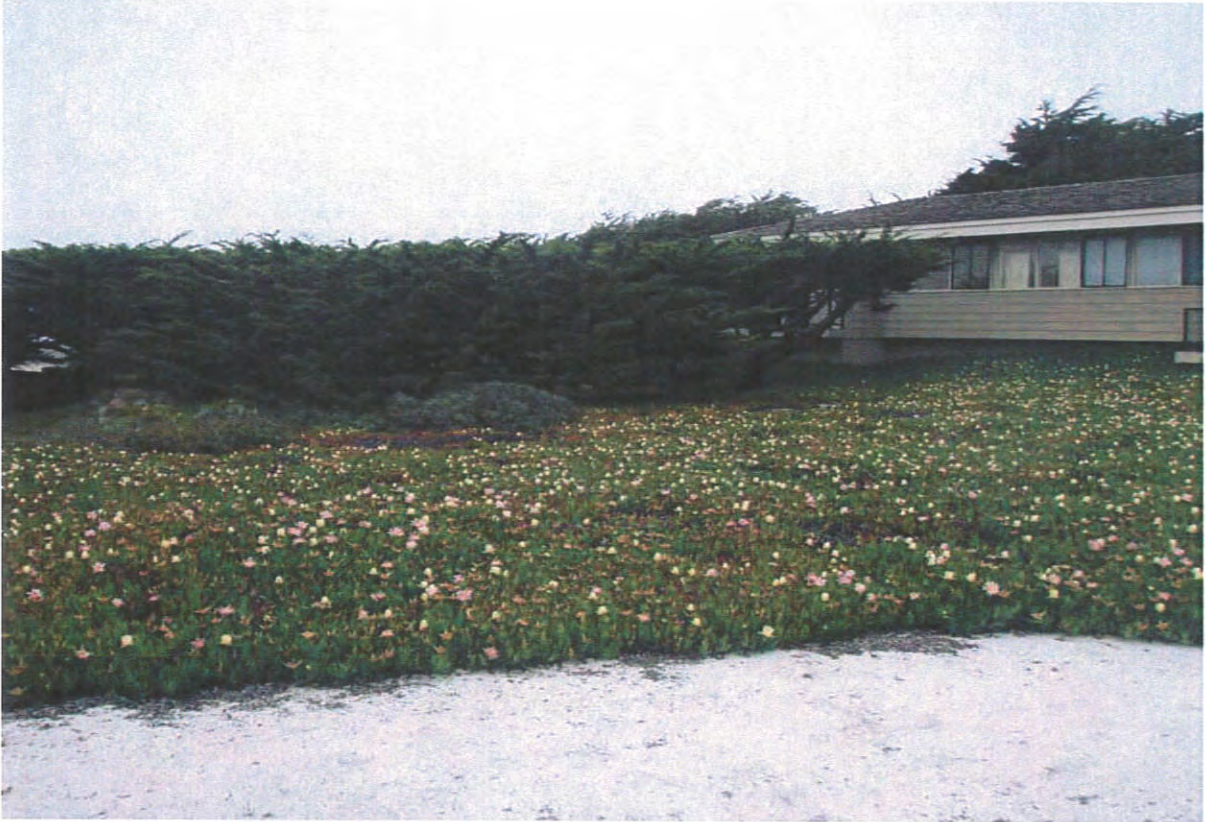
Extensive iceplant mat surrounds south side of house

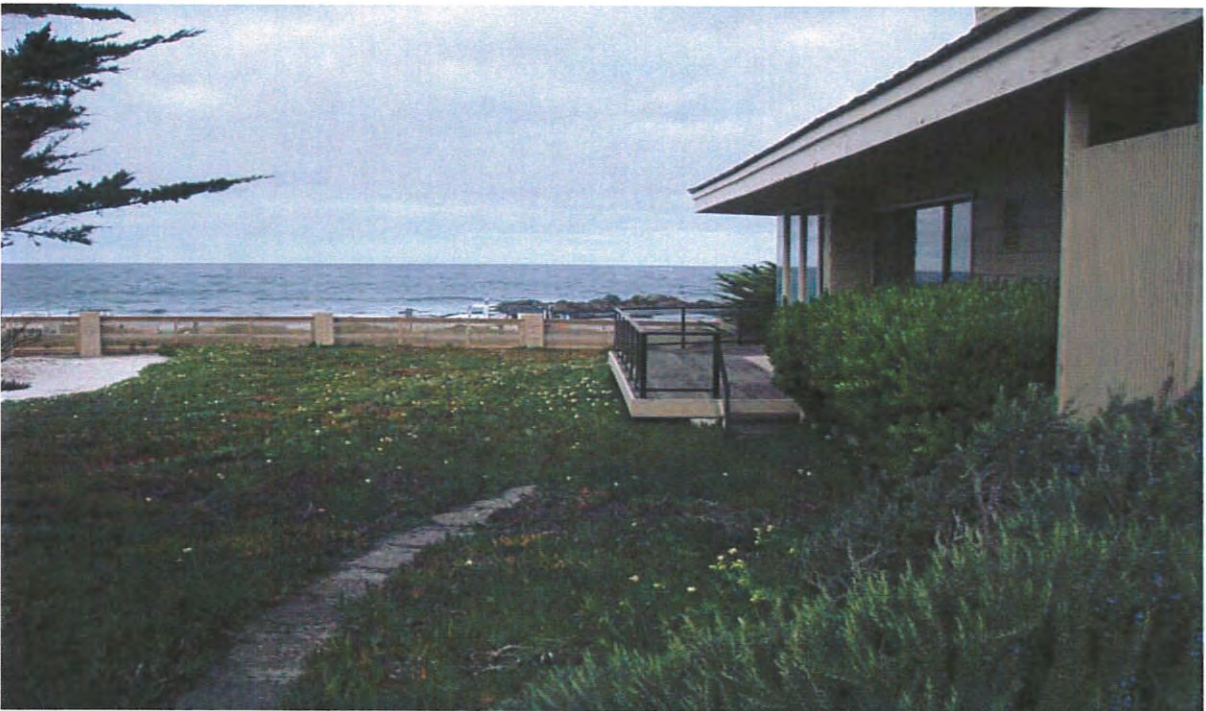
Iceplant mat on south side of house looking west

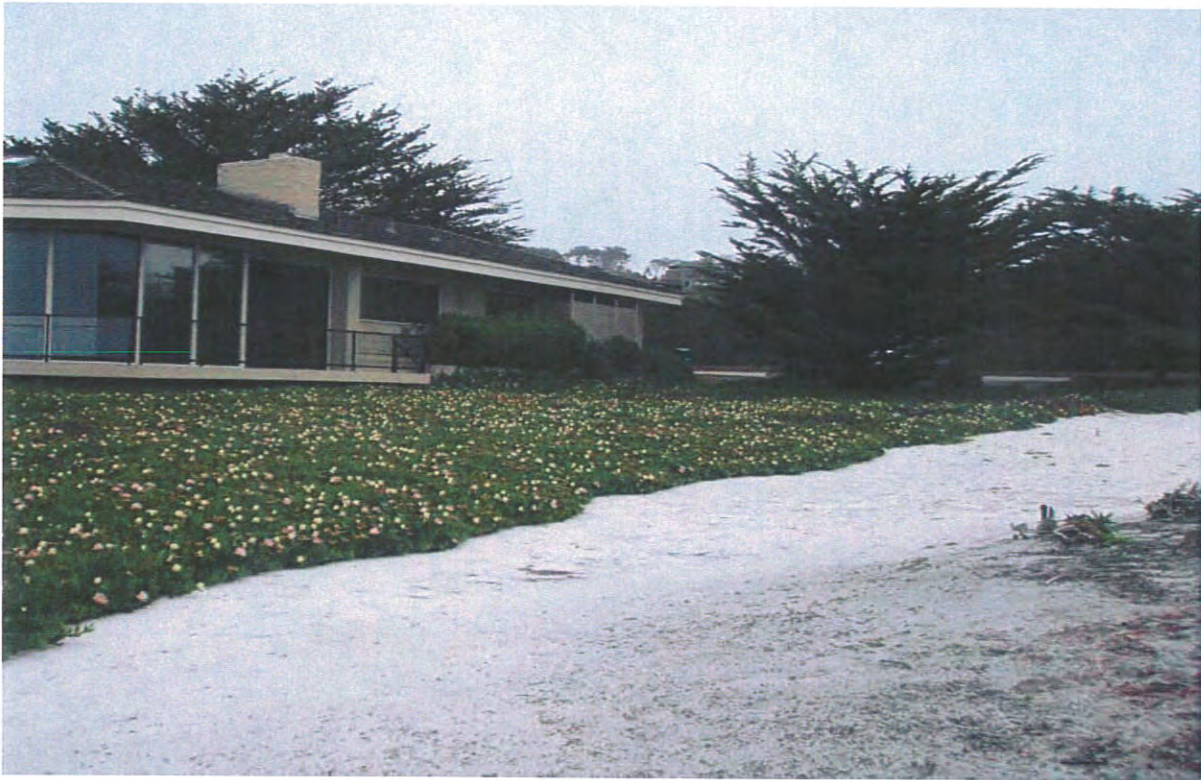
Sculpted sandy area at edge of iceplant mat

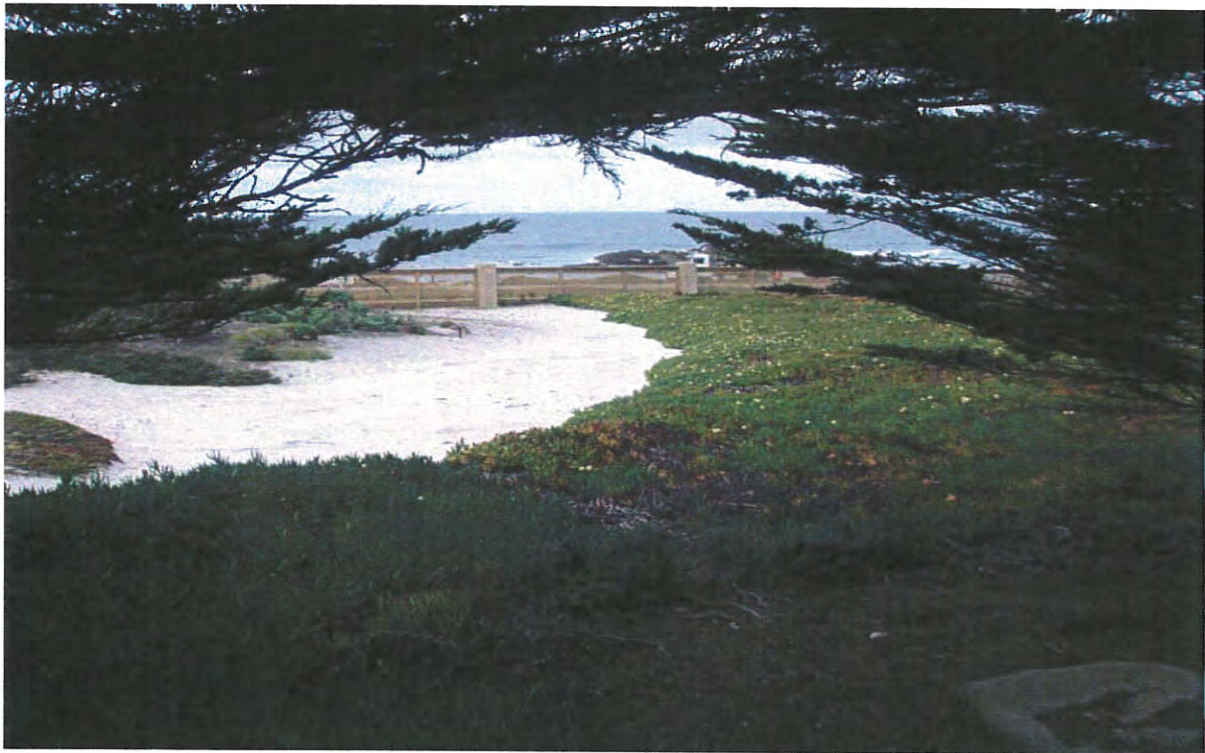
Open sand and iceplant mat through cypress canopy along driveway

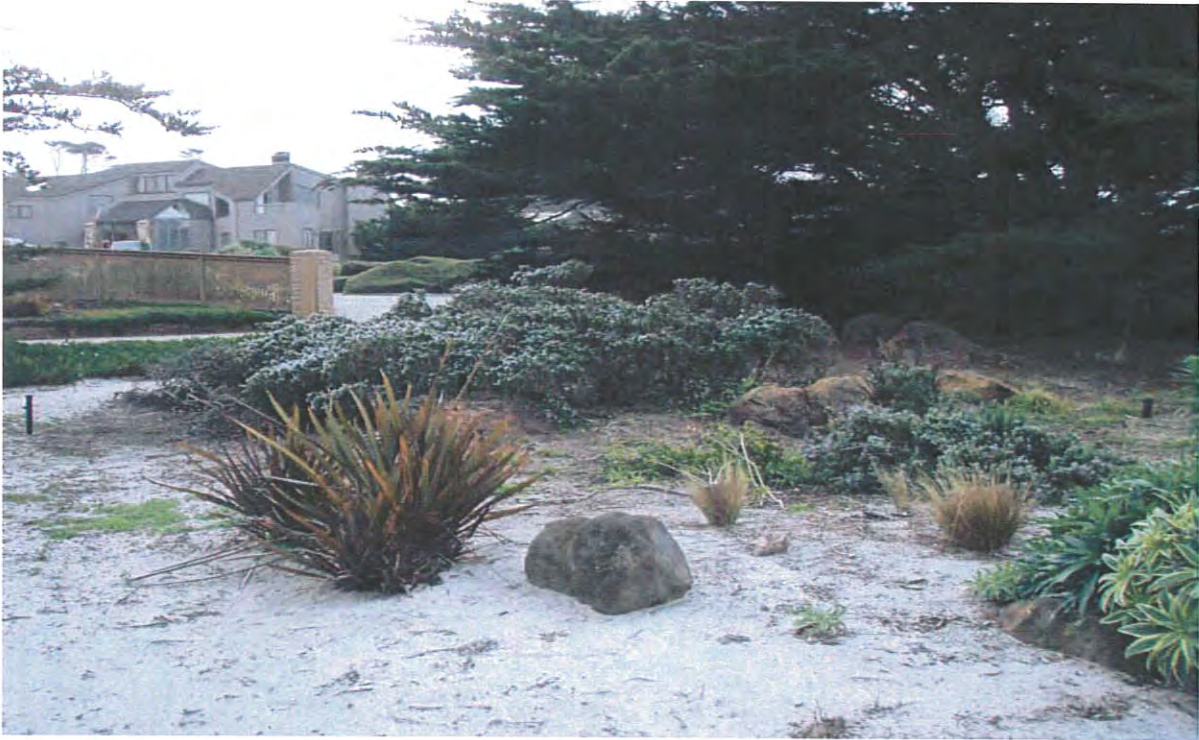
Mixed landscape area west of driveway to existing house

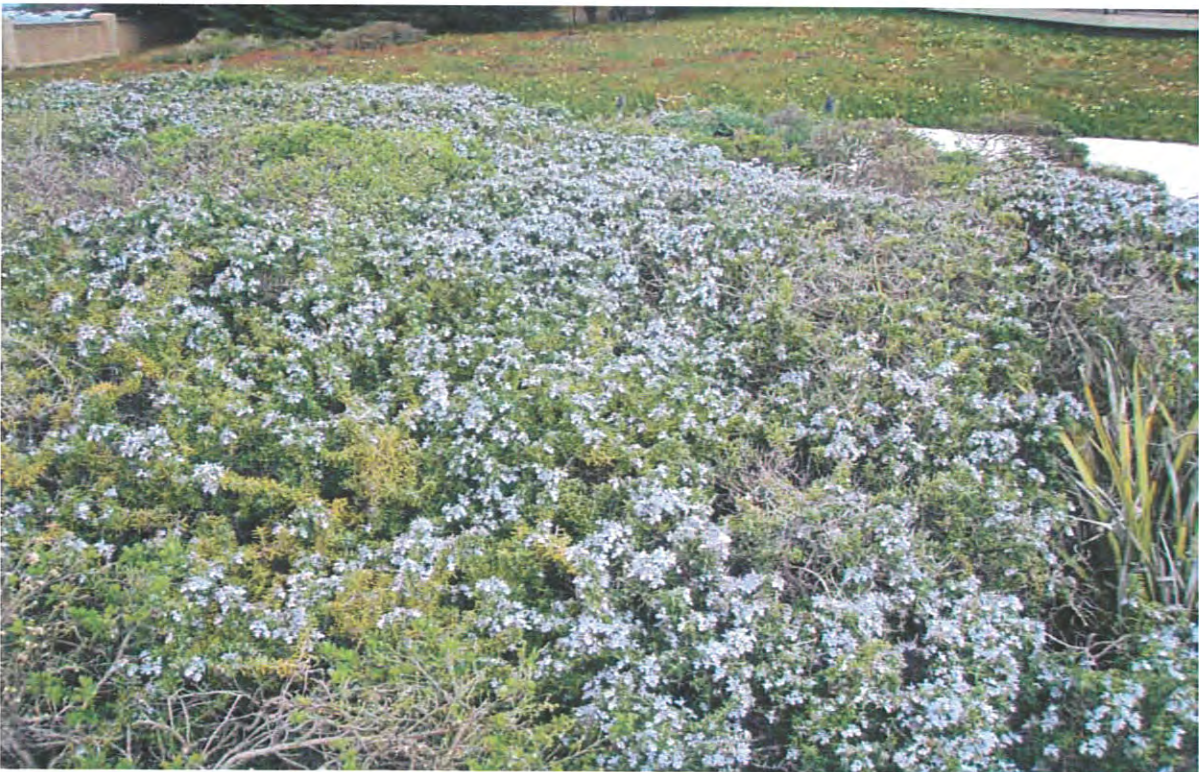
On closer examination, vegetation is non-native dominated by rosemary

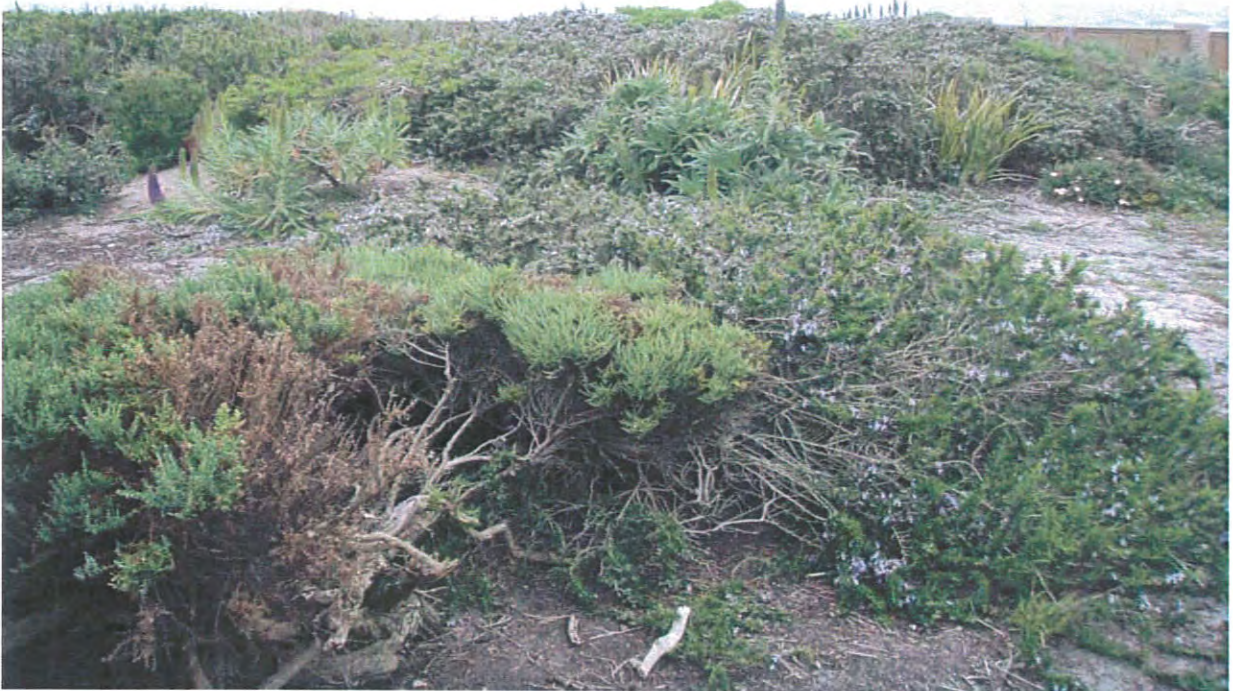
Some natives like mock heather (foreground) are mixed with non-natives in landscape

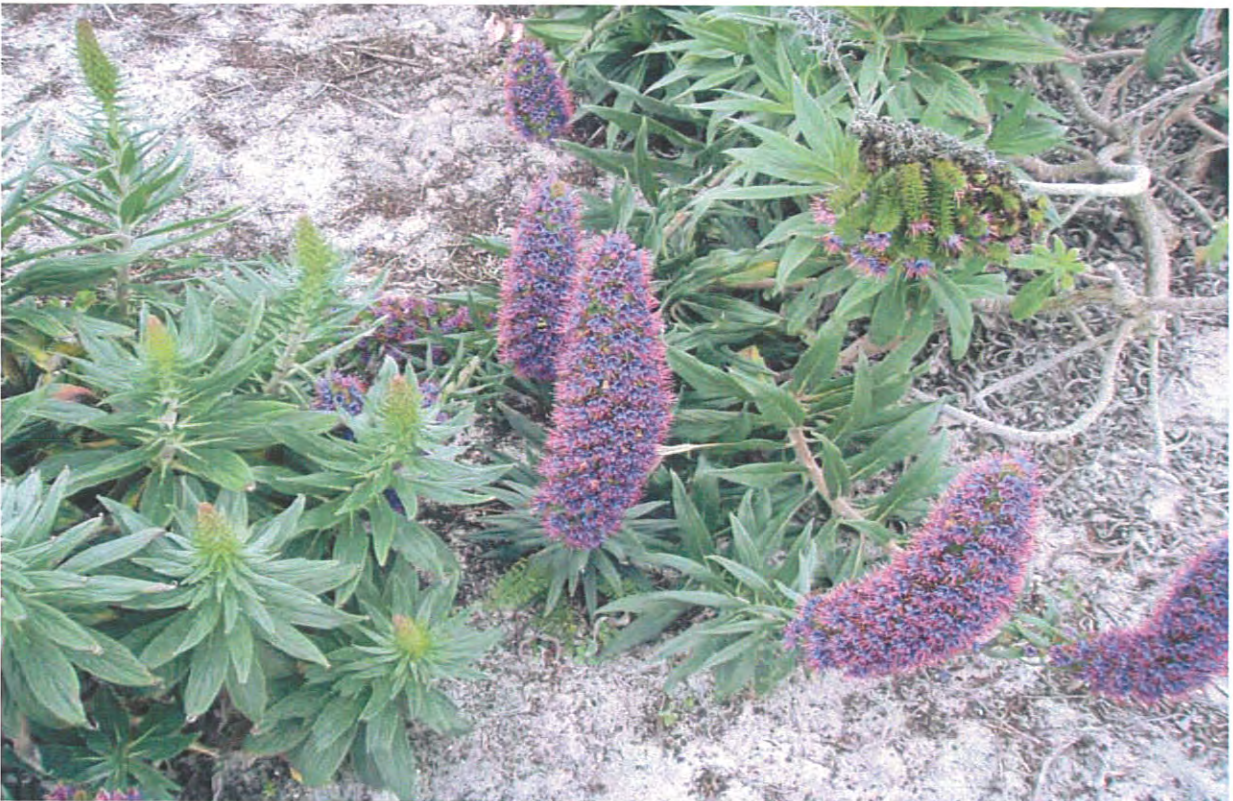
Non native *Echium* sp. in mixed landscape area

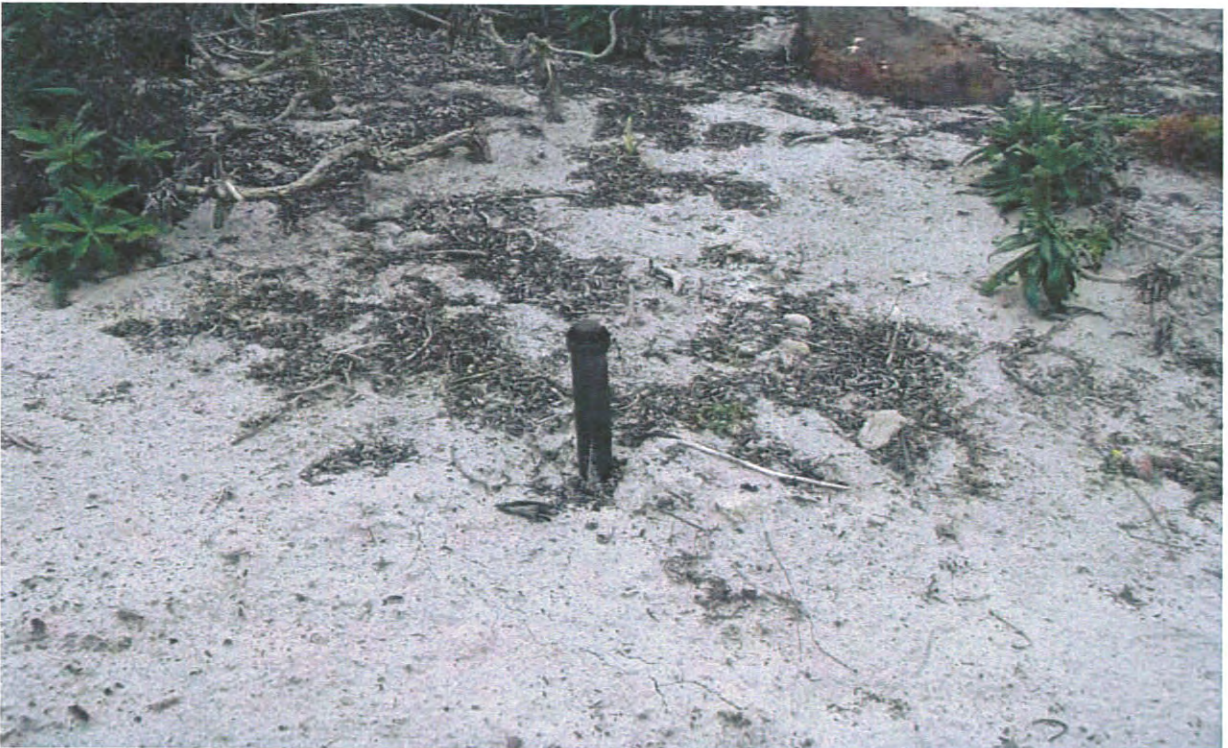
Sprinkler head at edge of mixed landscape area

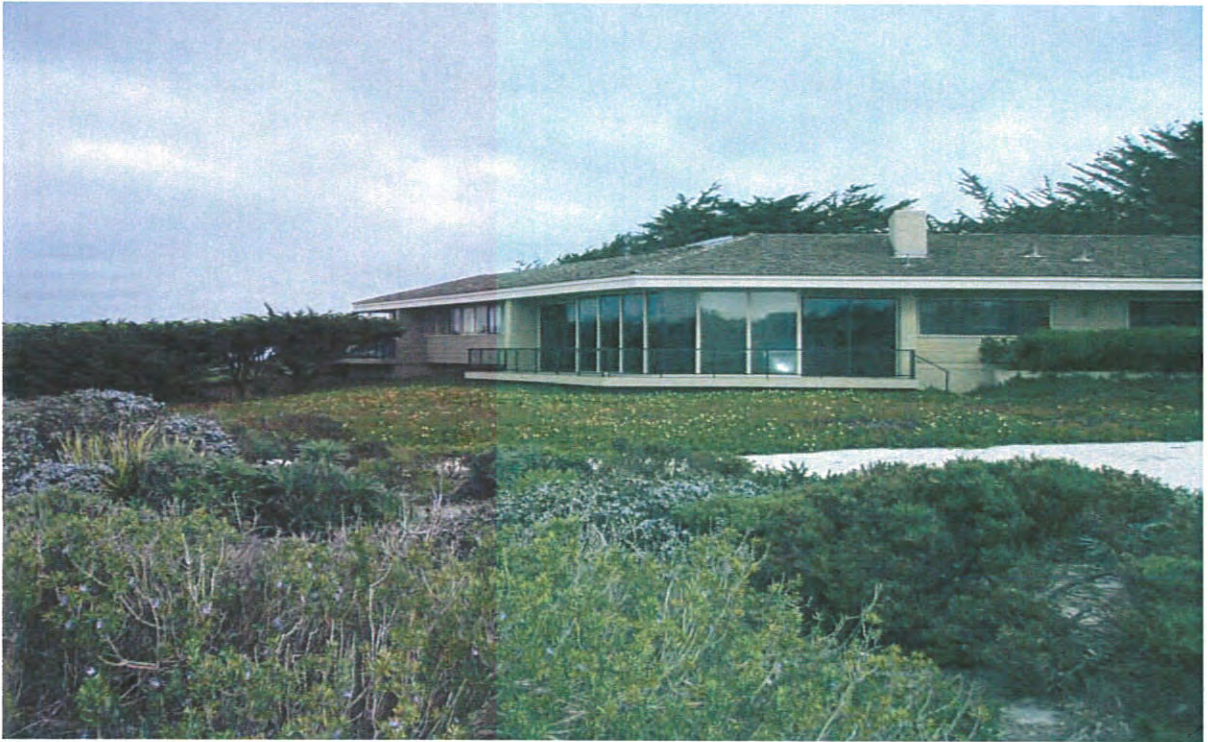
Area of restoration potential south of existing house

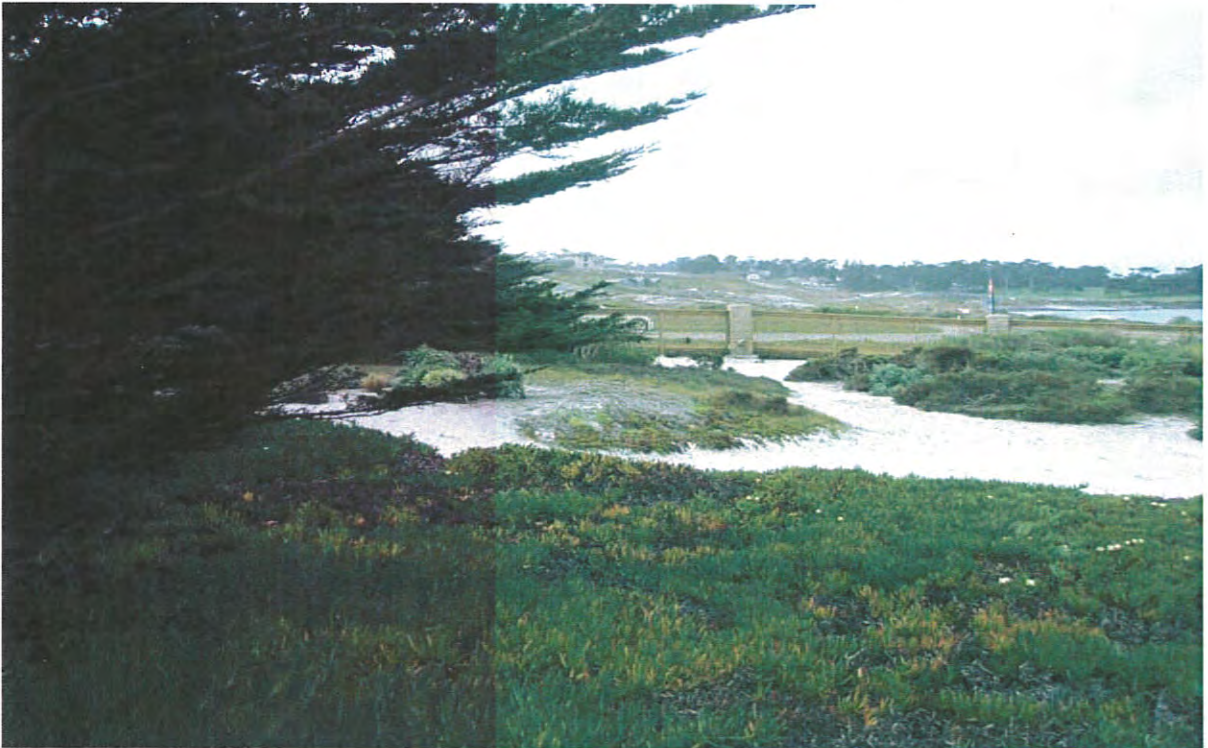
Potential dune habitat restoration area
