## MONTEREY COUNTY PLANNING COMMISSION

<b>Meeting:</b> February 25, 2015	<b>Agenda Item No.:</b> 2
<b>Project Description:</b> Consider a Combined Development Permit consisting of an Administrative Permit and Design Approval for the construction of a 4,993 square foot single family dwelling with a 646 square foot detached garage within the site plan review zoning district; a Use Permit for the removal of 26 coast live oak trees; a Use Permit for the development on slopes exceeding 30%	
<b>Project Location:</b> 12 San Clemente Trail, Carmel	<b>APN:</b> 239-091-043-000
<b>Planning File Number:</b> PLN140660	<b>Owner:</b> Jeff & Medina Earl <b>Applicant &amp; Agent:</b> Ross Garland
<b>Planning Area:</b> Greater Monterey Peninsula Area Plan	<b>Flagged and staked:</b> Yes
<b>Zoning Designation:</b> RC/40/D-S [Resource Conservation, 40 acres per unit with Design Control, and Site Plan Review Overlays]	
<b>CEQA Action:</b> Previously certified Final EIR for the Santa Lucia Preserve, Resolution No. 94-005

EARL RESIDENCE

SAN CLEMENTE TRAIL, LOT 118, CARMEL, CA

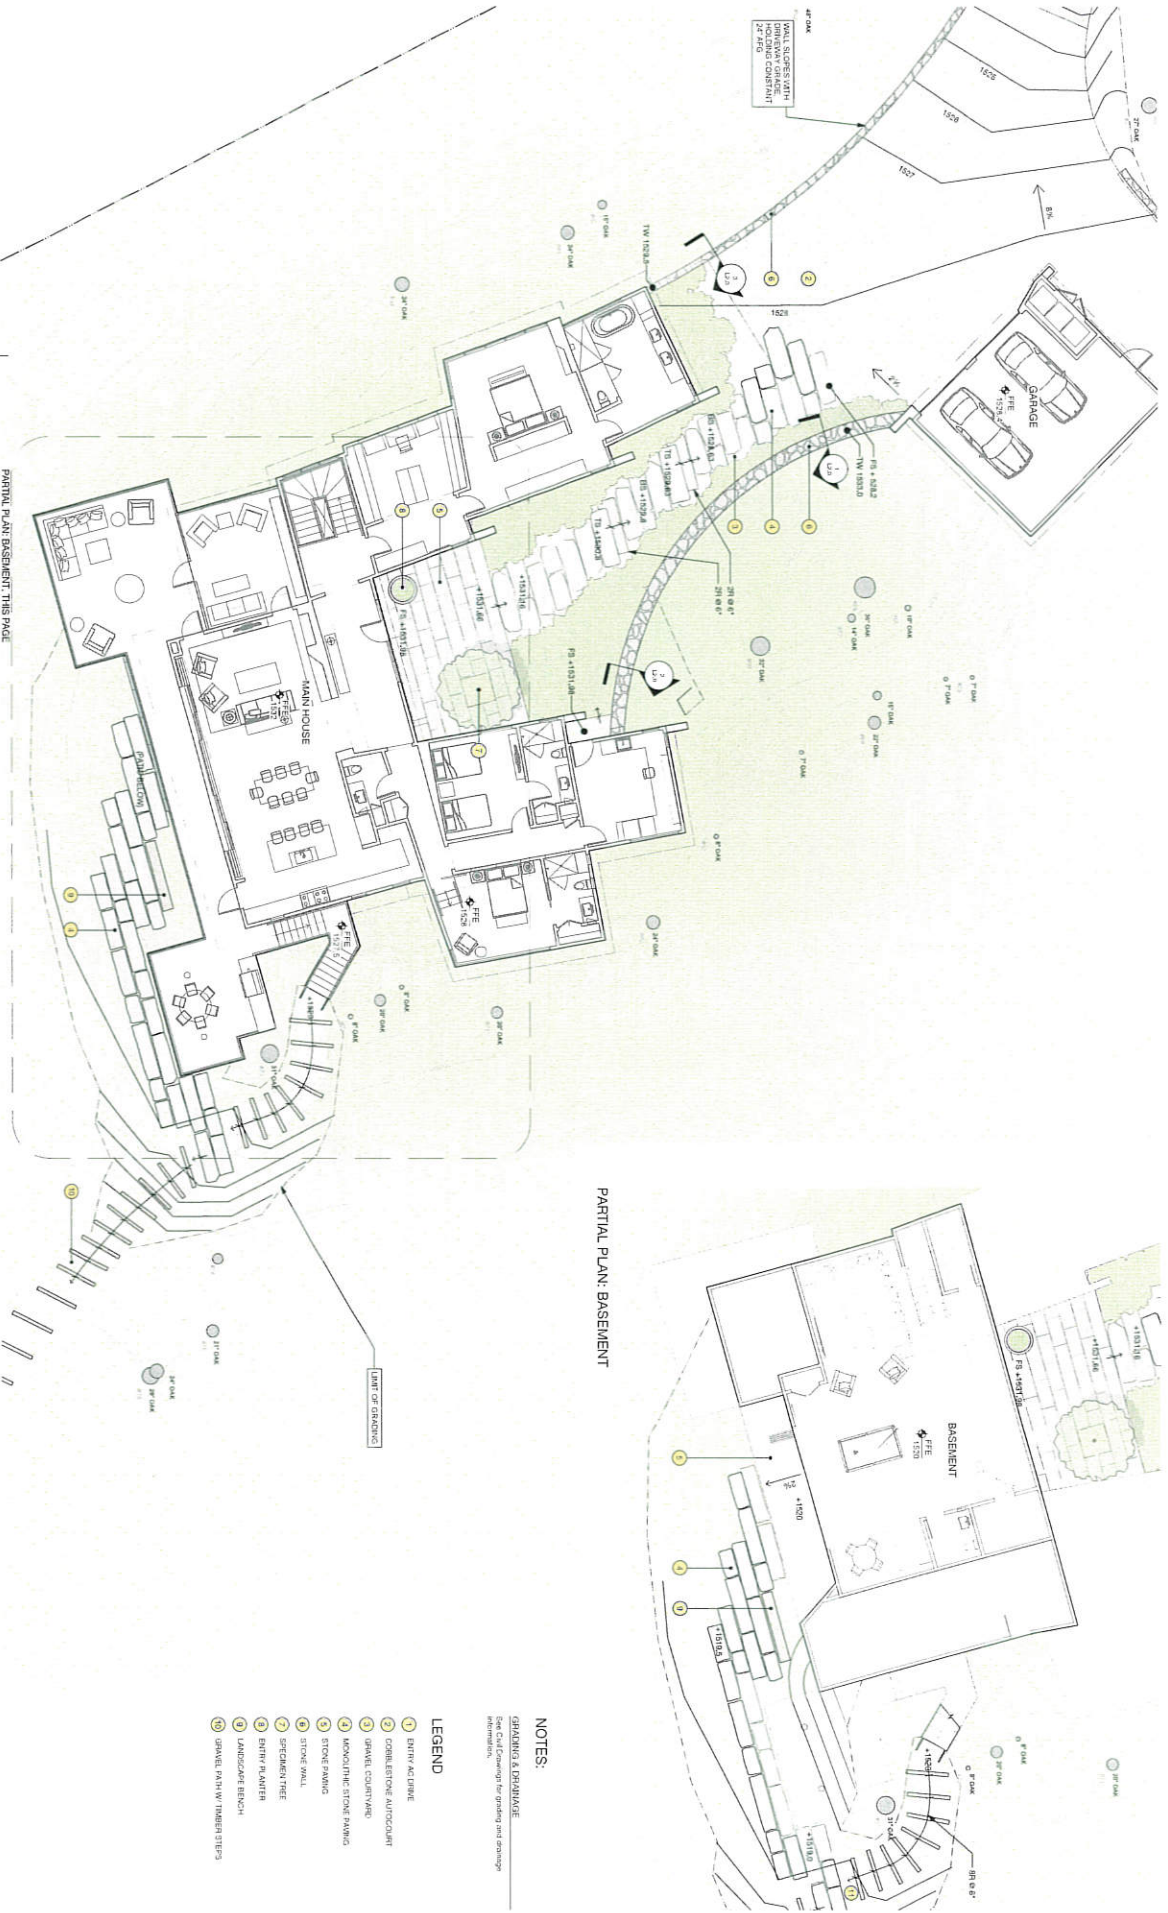
L1.1

- 1 ENTRY AC CURB
- 2 CORNELIUS AUTOCLAMP
- 3 GRAVEL COURTYARD
- 4 MONOLITHIC STONE PAVING
- 5 STONE WALL
- 6 SPREADER TREE
- 7 ENTRY PLANTER
- 8 LANDSCAPE BENCH
- 9 GRAVEL PATH WITH TREES

GRAVEL & SPREADER  
 See Callout for grading and drainage information.

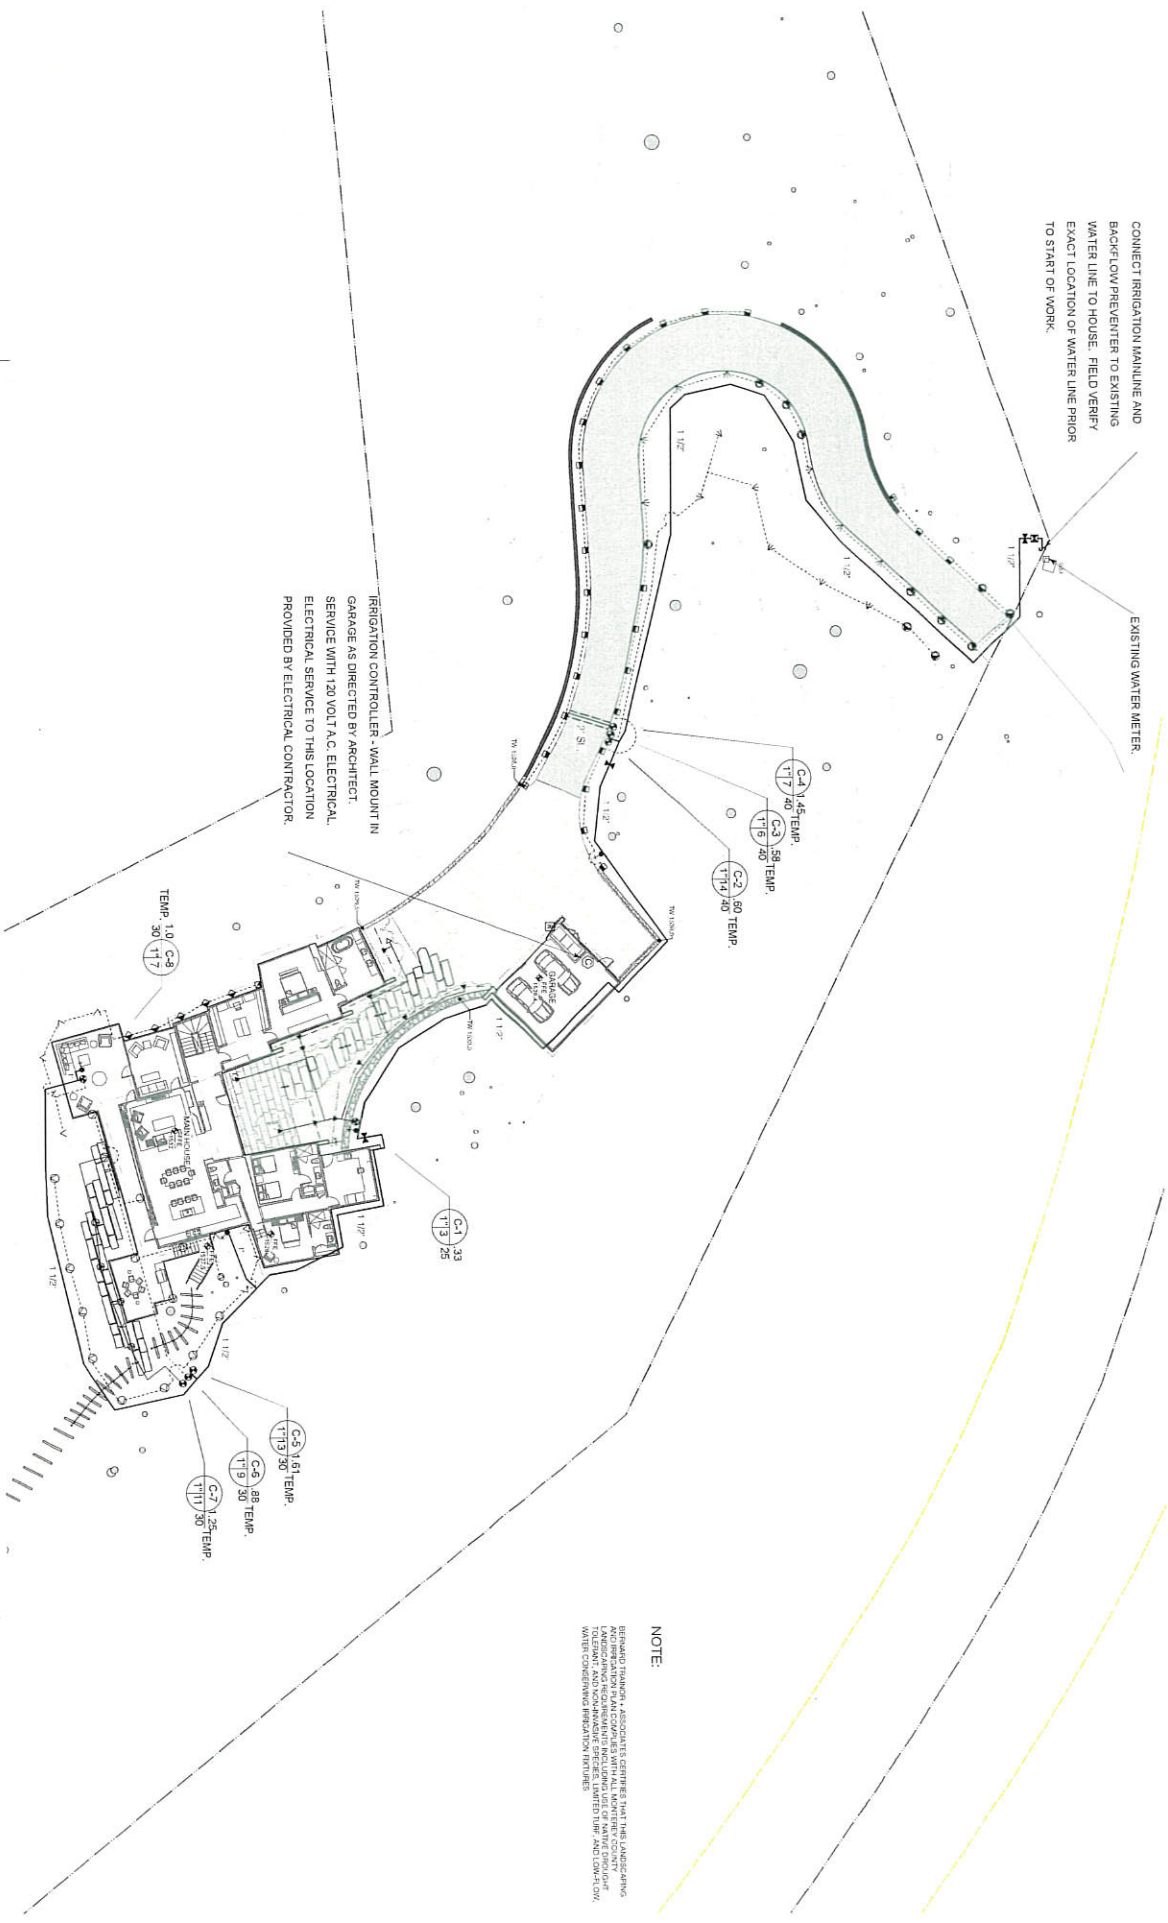
# EARL RESIDENCE | SAN CLEMENTE TRAIL, LOT 118, CARMEL, CA IRRIGATION PLAN

EXISTING WATER METER.

IRRIGATION CONTROLLER - WALL MOUNT IN  
GARAGE AS DIRECTED BY ARCHITECT.  
SERVICE WITH 120 VOLT A.C. ELECTRICAL.  
ELECTRICAL SERVICE TO THIS LOCATION  
PROVIDED BY ELECTRICAL CONTRACTOR.

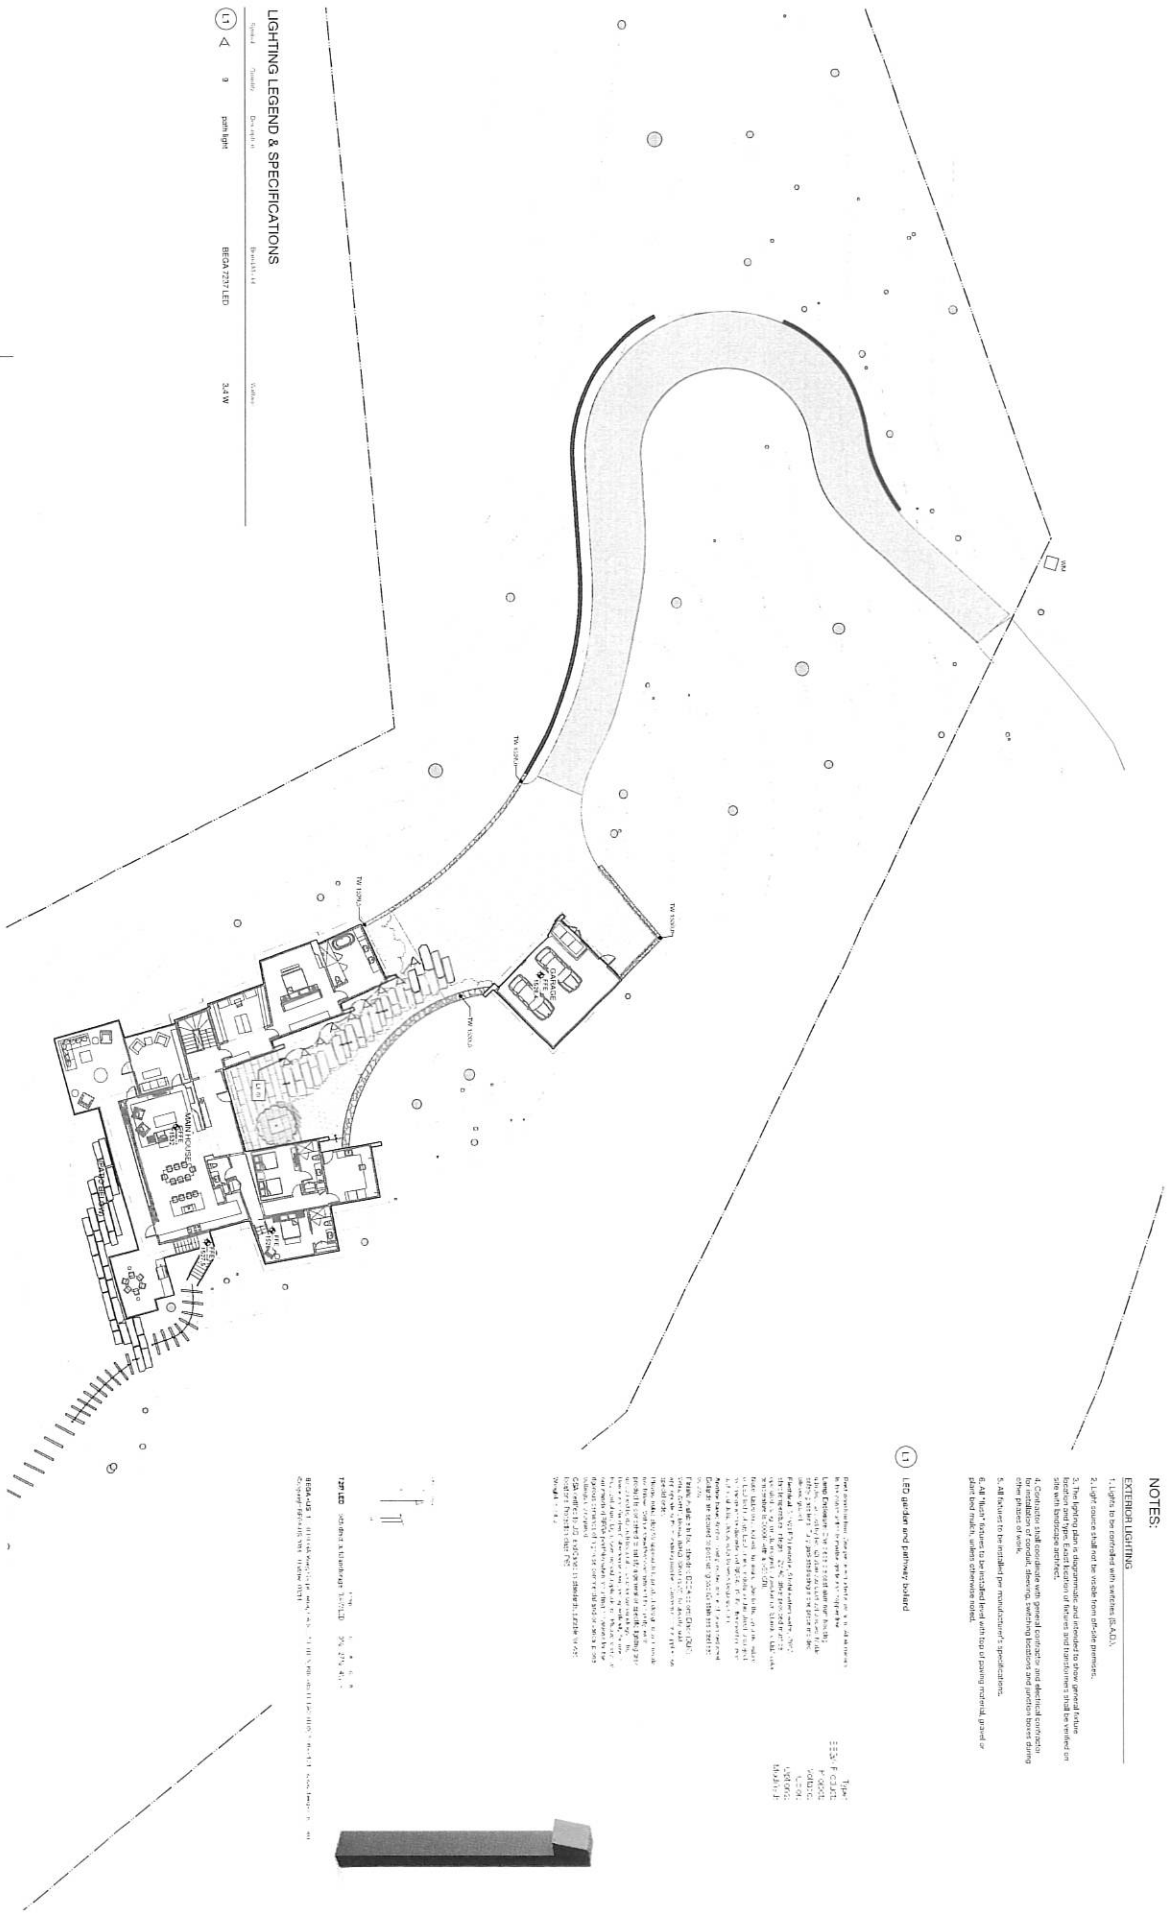
**LIGHTING LEGEND & SPECIFICATIONS**

Symbol	Quantity	Description	Manufacturer	Notes
(1)	3	path light	RECA 2707 LED	3.4W

(1) LED garden and pathway bollard

**Condition/Mitigation Monitoring Measure:** All exterior lighting shall be unobtrusive, down-lit, harmonious with the local area, and constructed or located so that only the intended area is illuminated and off-site glare is fully controlled. The lighting source shall be shielded and recessed into the fixture. The applicant shall submit three (3) copies of an exterior lighting plan which shall indicate the location, type, and wattage of all light fixtures and include catalog sheets for each fixture. The lighting shall comply with the requirements of the California Energy Code set forth in California Code of Regulations Title 24 Part 6. The exterior lighting plan shall be subject to approval by the Director of RMA - Planning, prior to the issuance of building permits.  
(RMA - Planning)

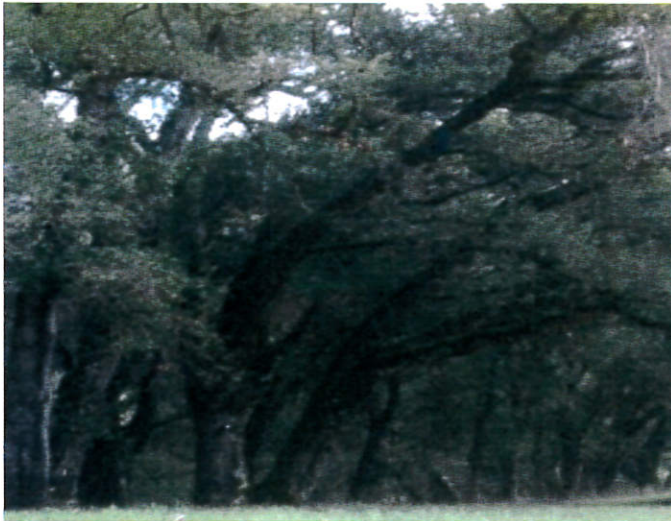
The building footprint location and driveway proposes the removal of smaller trees which are abundant in this portion of the site. The lower level area of the homeland is more densely forested with larger diameter trees (pictured below).

After significant review and design consideration it was determined that the building area proposed is the most appropriate for preserving the tree resources on this site.

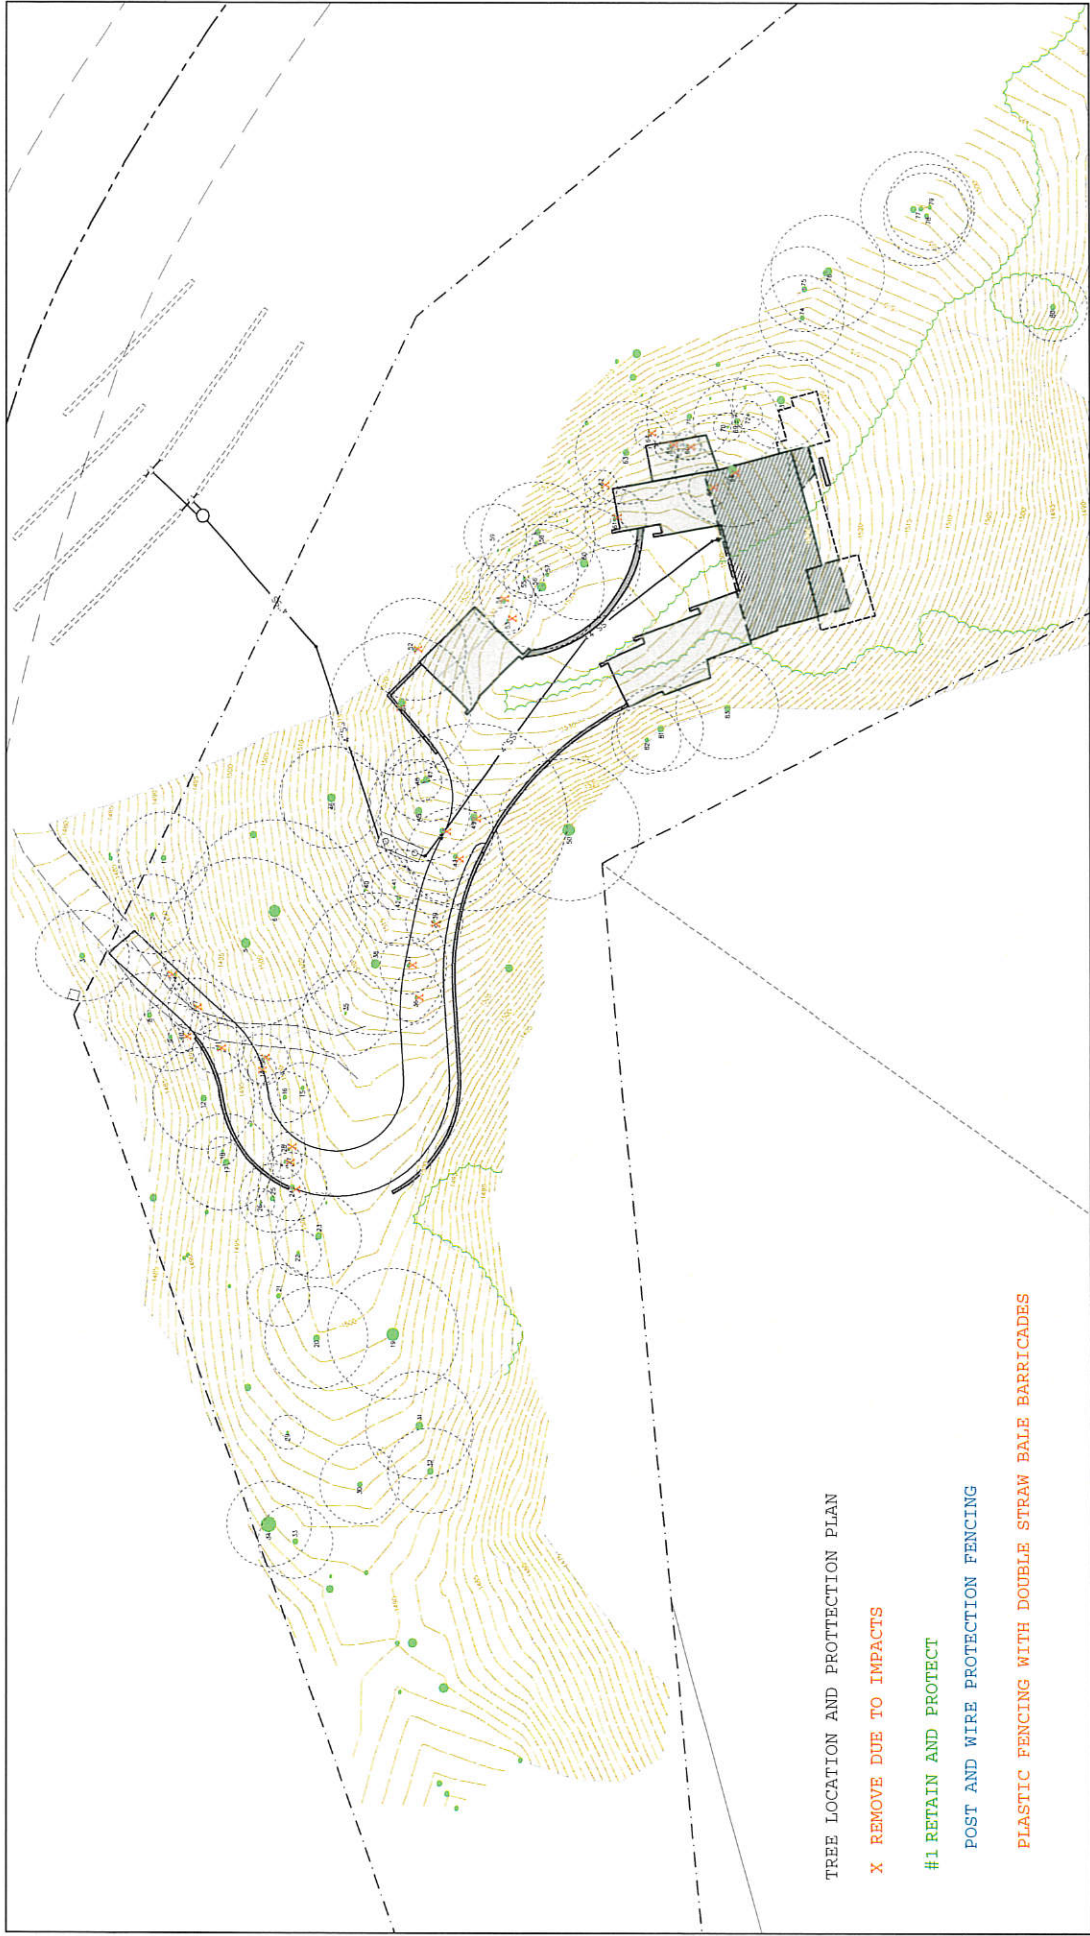
TREE LOCATION AND PROTECTION PLAN

X REMOVE DUE TO IMPACTS

A total of 26 trees are proposed for removal due to the driveway (14), detached garage and turn around for emergency access (4), and the house (7). Development of the driveway would require tree removal regardless of where the house would be located. The Tree Implementation Plan written by Maureen Hamb recommends the replacement ratio required by the Santa Lucia Preserve, 3:1 for trees less than 24 inches in diameter, and 5:1 for trees greater than 24 inches in diameter. This will result in the replacement of 84 trees. The Tree Implementation Plan also provides recommendations for tree protection and fencing. Given the constraints onsite and the necessary regulations for emergency access, the proposed tree removal is the minimum necessary for the proposed development.

- c) The Tree Protection Plan submitted by Maureen Hamb inventoried a total of 83 trees adjacent to the proposed development site, and an additional 200 trees are located elsewhere on the property. The project requires 26 trees to be removed, and the plan recommends tree protection for the 57 remaining trees adjacent to the project. The report states that the overall health of the trees on the property is fair, as many of the coast live oak trees contained within lot #118 have been infected by sudden oak death syndrome.
